Home Report

5 Rockfield Crescent
Dundee DD2 1JE

single survey

Property address	5 Rockfield Crescent Dundee DD2 1JE
Customer	Suleman Sakur
Prepared by	Graham + Sibbald LLP

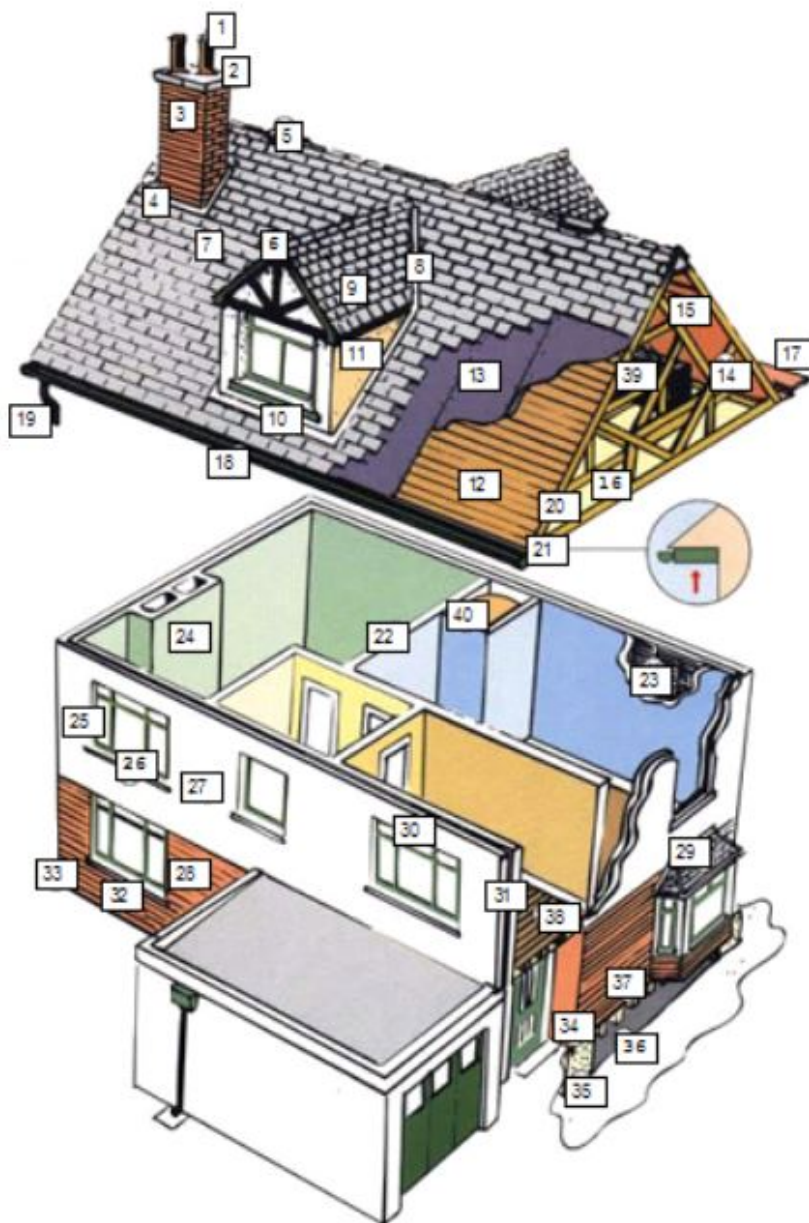
Sectional Diagram showing elements of a typical house

1	Chimney pots
2	Coping stone
3	Chimney head
4	Flashing
5	Ridge ventilation
6	Ridge board
7	Slates/tiles
8	Valley guttering
9	Dormer projection
10	Dormer flashing
11	Dormer cheeks
12	Sarking
13	Roof felt
14	Trusses
15	Collar
16	Insulation
17	Parapet gutter
18	Eaves guttering
19	Rainwater downpipe
20	Verge boards / skewes
21	Soffit boards
22	Partition wall
23	Lath / plaster
24	Chimney breast
25	Window pointing
26	Window sills
27	Rendering
28	Brickwork / pointing
29	Bay window projection
30	Lintels
31	Cavity walls / wall ties
32	Subfloor ventilator
33	Damp proof course
34	Base course
35	Foundations
36	Solum
37	Floor joists
38	Floorboards
39	Water tank
40	Hot water tank

Reference may be made in this report to some or all of the above component parts of the property. This diagram may assist you in locating and understanding these items.

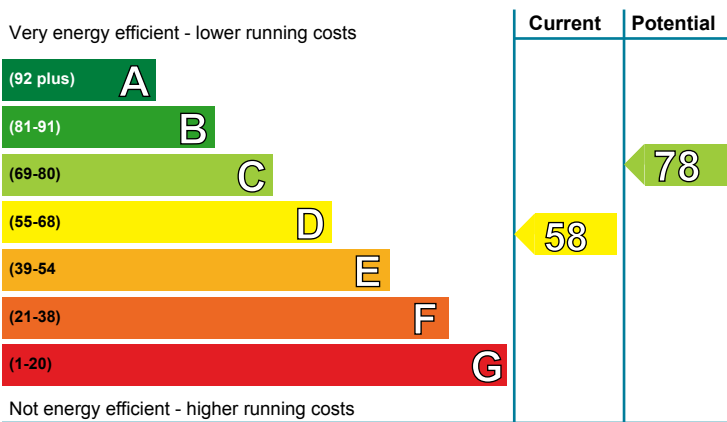
Energy Efficiency Rating

This graph shows the current efficiency of your home, taking into account both energy efficiency and fuel costs. The higher this rating, the lower your fuel bills are likely to be.

Your current rating is **band D (58)**. The average rating for EPCs in Scotland is **band D (61)**.

The potential rating shows the effect of undertaking all of the improvement measures listed within your recommendations report.

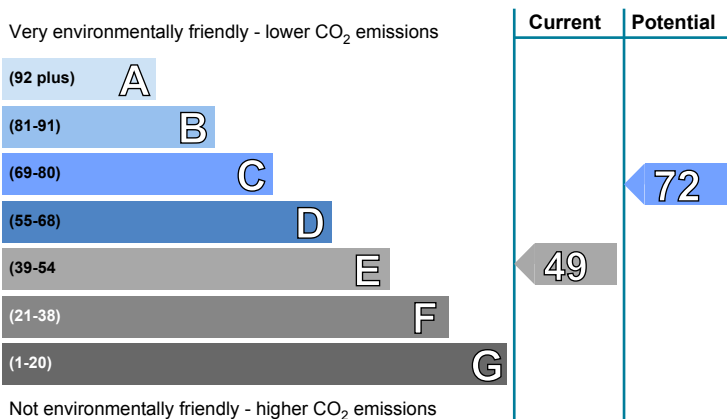
Environmental Impact (CO₂) Rating

This graph shows the effect of your home on the environment in terms of carbon dioxide (CO₂) emissions. The higher the rating, the less impact it has on the environment.
