Single Survey

survey report on:

Property address	14 Challum Crescent, Broughty Ferry, Dundee, DD5 3SY
-------------------------	---------------------------------------------------------------

Date of inspection	30th October 2024
---------------------------	-------------------

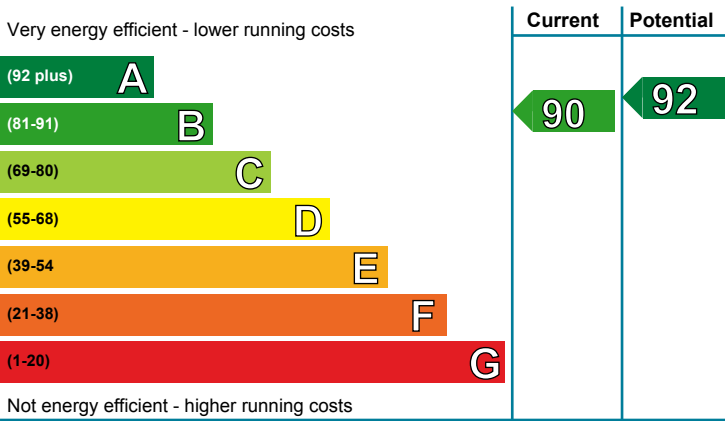
Energy Efficiency Rating

This graph shows the current efficiency of your home, taking into account both energy efficiency and fuel costs. The higher this rating, the lower your fuel bills are likely to be.

Your current rating is **band B (90)**. The average rating for EPCs in Scotland is **band D (61)**.

The potential rating shows the effect of undertaking all of the improvement measures listed within your recommendations report.

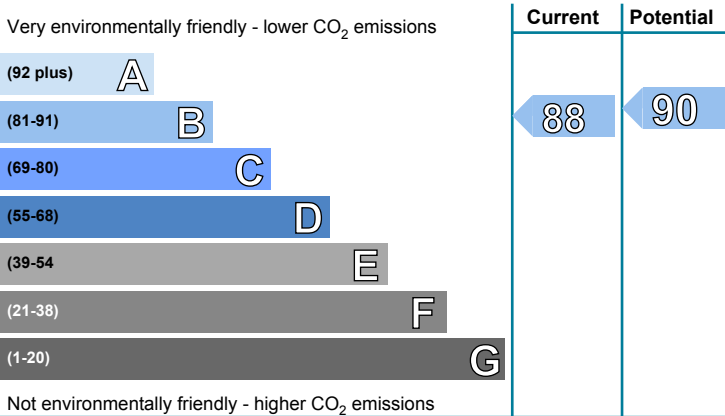
Environmental Impact (CO₂) Rating

This graph shows the effect of your home on the environment in terms of carbon dioxide (CO₂) emissions. The higher the rating, the less impact it has on the environment.

The potential rating shows the effect of undertaking all of the improvement measures listed within your recommendations report.

The average Scottish household produces about 6 tonnes of carbon dioxide every year. Based on this assessment, heating and lighting this home currently produces approximately 1.5 tonnes of carbon dioxide every year. Adopting recommendations in this report can reduce emissions and protect the environment. If you were to install all of these recommendations this could reduce emissions by 0.2 tonnes per year. You could reduce emissions even more by switching to renewable energy sources.
