# Home Report

Flat 1, 6 Claypotts Road  
Broughty Ferry Dundee DD5 1BX

# Single Survey

Property Address	Flat 1, 6 Claypotts Road Dundee DD5 1BX
Customer	Gillies of Broughty Ferry Limited
Prepared by	Graham + Sibbald LLP
Date of Inspection	09/04/2025

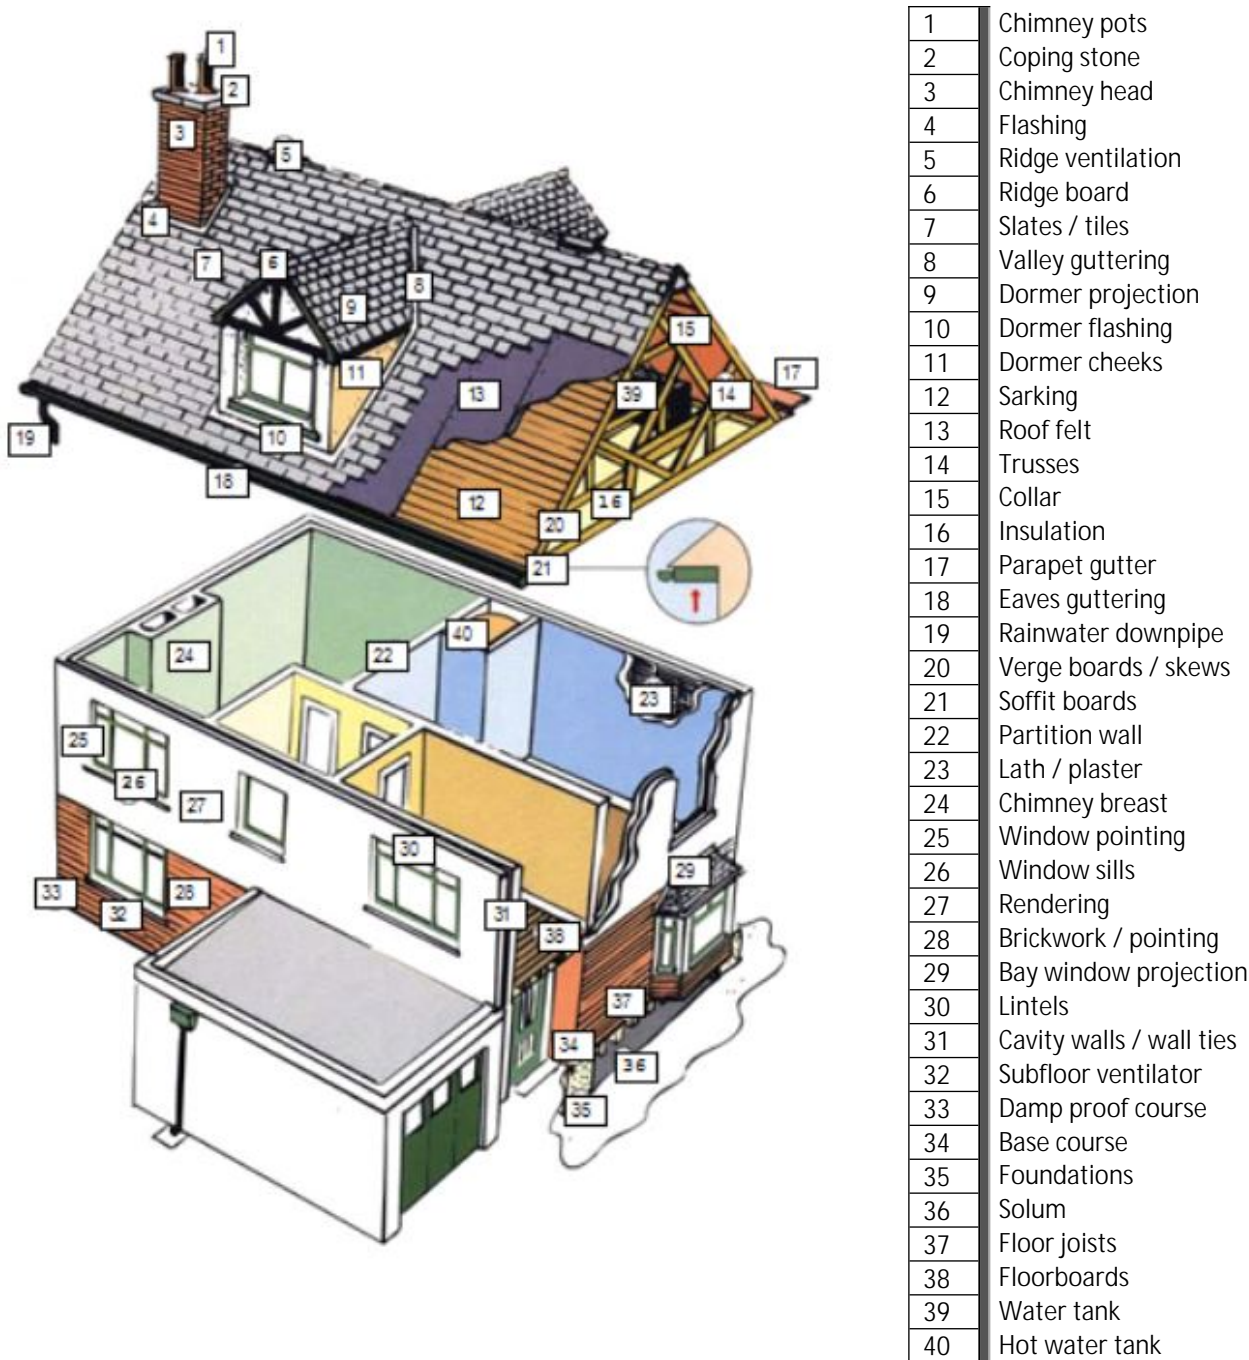
# Sectional diagram showing elements of a typical house

Reference may be made in this report to some or all of the above component parts of the property. This diagram may assist you in locating and understanding these items.
