# Home Report

15 Monifieth Road Broughty Ferry Dundee DD5 2RN

# Single Survey

Property Address	15 Monifieth Road Dundee DD5 2RN
Customer	Miss Margaret Mackie
Prepared by	Graham + Sibbald Property Consultants Limited

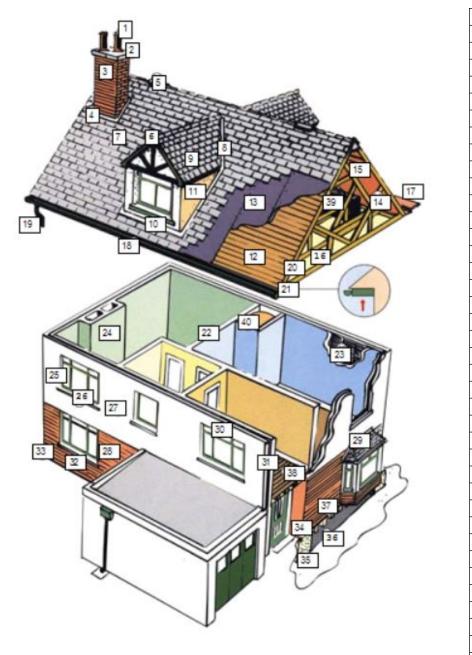
#### Sectional diagram showing elements of a typical house

Chimney pots
Coping stone
Chimney head
Flashing
Ridge ventilation
Ridge board
Slates / tiles
Valley guttering
Dormer projection
Dormer flashing
Dormer cheeks
Sarking
Roof felt
Trusses
Collar
Insulation
Parapet gutter
Eaves guttering
Rainwater downpipe
Verge boards / skews
Soffit boards
Partition wall
Lath / plaster
Chimney breast
Window pointing
Window sills
Rendering
Brickwork / pointing
Bay window projection
Lintels
Cavity walls / wall ties
Subfloor ventilator
Damp proof course
Base course
Foundations
Solum
Floor joists
Floorboards
Water tank
Hot water tank

Reference may be made in this report to some or all of the above component parts of the property. This diagram may assist you in locating and understanding these items.
