Home Report

2B Dalhousie Street Carnoustie DD7 6EJ

Single Survey

Survey report on:

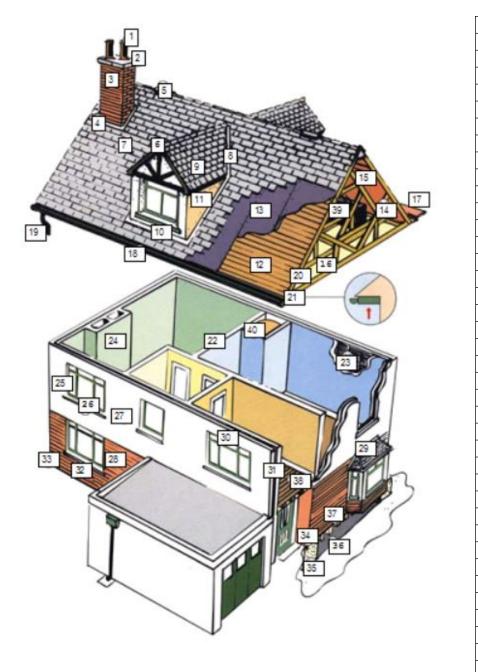
Sectional diagram showing elements of a typical house

_
1	Chimney pots
2	Coping stone
3	Chimney head
4	Flashing
5	Ridge ventilation
6	Ridge board
7	Slates / tiles
8	Valley guttering
9	Dormer projection
10	Dormer flashing
11	Dormer cheeks
12	Sarking
13	Roof felt
14	Trusses
15	Collar
16	Insulation
17	Parapet gutter
18	Eaves guttering
19	Rainwater downpipe
20	Verge boards / skews
21	Soffit boards
22	Partition wall
23	Lath / plaster
24	Chimney breast
25	Window pointing
26	Window sills
27	Rendering
28	Brickwork / pointing
29	Bay window projection
30	Lintels
31	Cavity walls / wall ties
32	Subfloor ventilator
33	Damp proof course
34	Base course
35	Foundations
36	Solum
37	Floor joists
38	Floorboards
39	Water tank
40	Hot water tank

Reference may be made in this report to some or all of the above component parts of the property. This diagram may assist you in locating and understanding these items.
