# Home Report

50F Seafield Road  
Dundee DD1 4NP

# Single Survey

| Prepared by | Graham + Sibbald Property Consultants Limited |

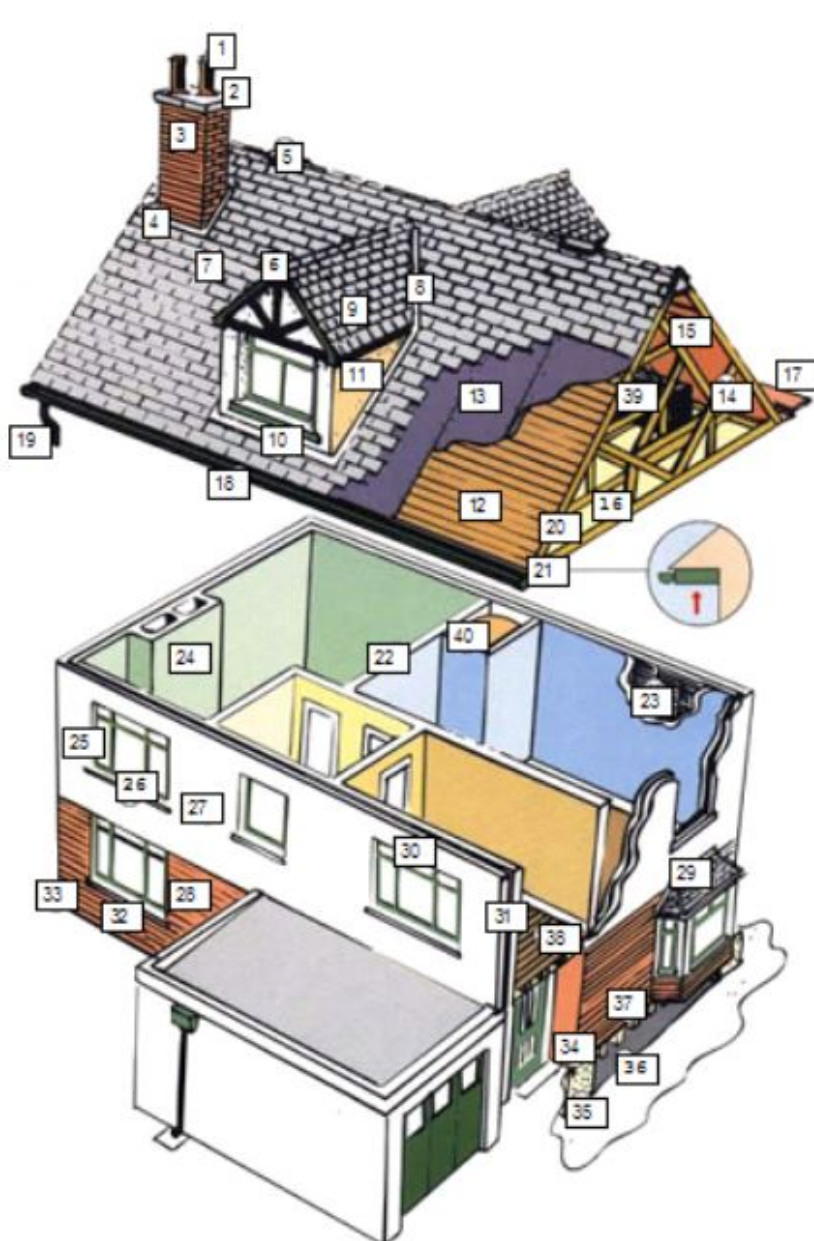
## Sectional diagram showing elements of a typical house

| 1 | Chimney pots |
| 2 | Coping stone |
| 35 | Foundations |
