Home Report

Single Survey

Property Address	6 Railway Court, Newtown St. Boswells, Melrose, Roxburghshire, TD6 0PW
	000505
Reference	988565
Customer Name	Ewan Wilson
Date of Inspection	24th March 2025
Surveyor's name, qualifications and office	Edina Matyasi BSc (Hons) AssocRICS DM Hall LLP Chartered Surveyors 4 Green Street Galashiels TD1 3AE Tel: 01896 752009 email: galashielsresidential@dmhall.co.uk

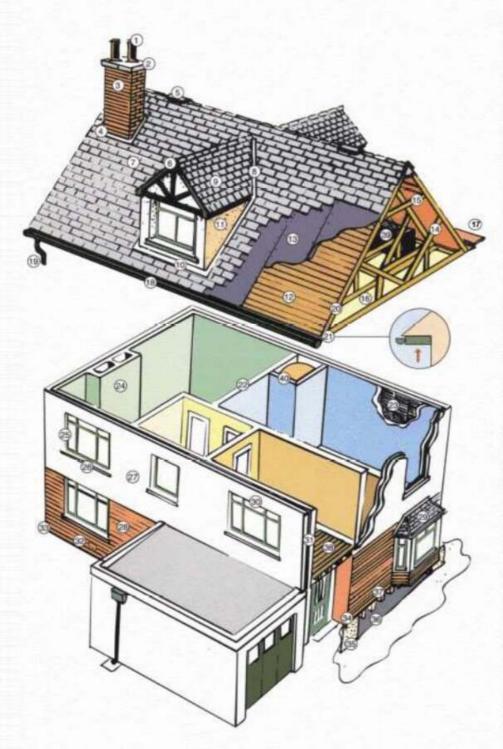
Sectional Diagram showing elements of a typical house

Reference may be made in this report to some or all of the above component parts of the property. This diagram may assist you in locating and understanding these items.

- 1) Chimney pots
- (2) Coping stone
- 3) Chimney head
- (4) Flashing
- (5) Ridge ventilation
- (6) Ridge board
- (7) Slates / tiles
- (8) Valley guttering
- 9 Dormer projection
- 10 Dormer flashing
- 11) Dormer cheeks
- (12) Sarking
- (13) Roof felt
- (14) Trusses
- (15) Collar
- (16) Insulation
- (17) Parapet gutter
- (18) Eaves guttering
- (19) Rainwater downpipe
- 20) Verge boards /skews
- (21) Soffit boards
- (22) Partition wall
- (23) Lath / plaster
- (24) Chimney breast
- (25) Window pointing
- (26) Window sills
- (27) Rendering
- (28) Brickwork / pointing
- (29) Bay window projection
- (30) Lintels
- (31) Cavity walls / wall ties
- (32) Subfloor ventilator
- (33) Damp proof course
- 34) Base course
- 35) Foundations
- 36) Solum
- (37) Floor joists
- 38) Floorboards
- 39 Water tank
- 40) Hot water tank
