10 New Holygate,  
Broxburn,  
West Lothian,  
EH52 5RN

# Home Report

## Survey Report on:

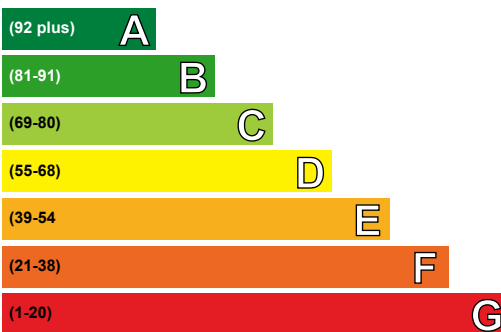
## Energy Efficiency Rating

Current	Potential
60	70

The potential rating shows the effect of undertaking all of the improvement measures listed within your recommendations report.
