7D Shore Road, Airth, Falkirk, Stirlingshire, FK2 8LH

Home Report

Single Survey

Property Address	7D Shore Road, Airth, Falkirk, Stirlingshire, FK2 8LH
Reference	1228050
Customer Name	Alistair Skakles
Date of Inspection	12th September 2025
Surveyor's name, qualifications and office	David Telford DM Hall LLP Chartered Surveyors Unit 6A, The Courtyard Callendar Business Park Falkirk FK1 1XR Tel: 01324 628321 email: centralresidential@dmhall.co.uk
Prepared By	DM Hall LLP

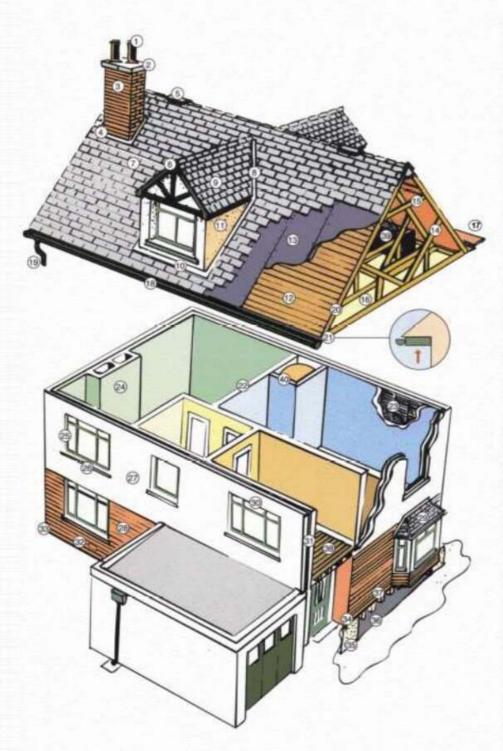
Sectional Diagram showing elements of a typical house

Reference may be made in this report to some or all of the above component parts of the property. This diagram may assist you in locating and understanding these items.

- 1) Chimney pots
- 2 Coping stone
- 3) Chimney head
- (4) Flashing
- (5) Ridge ventilation
- 6) Ridge board
- (7) Slates / tiles
- (8) Valley guttering
- 9 Dormer projection
- 10 Dormer flashing
- 11) Dormer cheeks
- (12) Sarking
- (13) Roof felt
- (14) Trusses
- (15) Collar
- (16) Insulation
- (17) Parapet gutter
- (18) Eaves guttering
- 19 Rainwater downpipe
- 20) Verge boards /skews
- (21) Soffit boards
- (22) Partition wall
- 23 Lath / plaster
- 24) Chimney breast
- (25) Window pointing
- (26) Window sills
- (27) Rendering
- (28) Brickwork / pointing
- (29) Bay window projection
- (30) Lintels
- (31) Cavity walls / wall ties
- 32) Subfloor ventilator
- (33) Damp proof course
- (34) Base course
- 35 Foundations
- 36) Solum
- (37) Floor joists
- 38) Floorboards
- 39 Water tank
- Hot water tank
