33 Ingleston Avenue, Denny, Stirlingshire, FK6 6QW

Home Report

Single Survey

Property Address	33 Ingleston Avenue, Denny, Stirlingshire, FK6 6QW
Reference	1038084
Customer Name	Mr Steven Bithell Mrs Michelle Bithell
Date of Inspection	18th November 2025
Surveyor's name, qualifications and office	Roddy Macdonald BLE FRICS BLE FRICS DM Hall LLP Chartered Surveyors Unit 6A, The Courtyard Callendar Business Park Falkirk FK1 1XR Tel: 01324 628321 email: centralresidential@dmhall.co.uk
Prepared By	DM Hall LLP

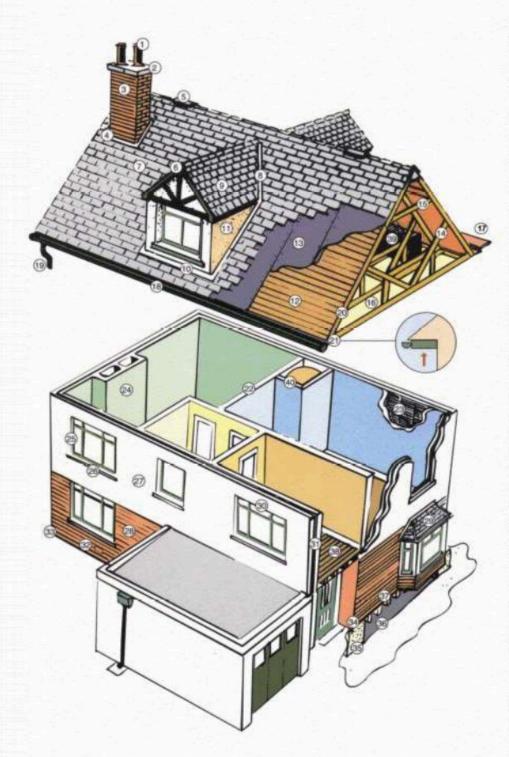
Sectional Diagram showing elements of a typical house

Reference may be made in this report to some or all of the above component parts of the property. This diagram may assist you in locating and understanding these items.

- 1) Chimney pots
- (2) Coping stone
- 3) Chimney head
- (4) Flashing
- (5) Ridge ventilation
- 6) Ridge board
- (7) Slates / tiles
- (8) Valley guttering
- 9 Dormer projection
- 10) Dormer flashing
- 11) Dormer cheeks
- (12) Sarking
- (13) Roof felt
- 14) Trusses
- (15) Collar
- 16) Insulation
- (17) Parapet gutter
- 18) Eaves guttering
- (19) Rainwater downpipe
- 20) Verge boards /skews
- (21) Soffit boards
- (22) Partition wall
- (23) Lath / plaster
- (24) Chimney breast
- (25) Window pointing
- (26) Window sills
- (27) Rendering
- (28) Brickwork / pointing
- (29) Bay window projection
- (30) Lintels
- (31) Cavity walls / wall ties
- (32) Subfloor ventilator
- (33) Damp proof course
- 34) Base course
- 35 Foundations
- 36) Solum
- (37) Floor joists
- 38) Floorboards
- 39) Water tank
- Hot water tank
