YOUR ONESURVEY HOME REPORT

Flat 0/2 26 Riccarton Street Glasgow G42 7NX

Single Survey

Prepared by	Gary Firth, MRICS
	Glasgow South - Allied Surveyors Scotland Ltd

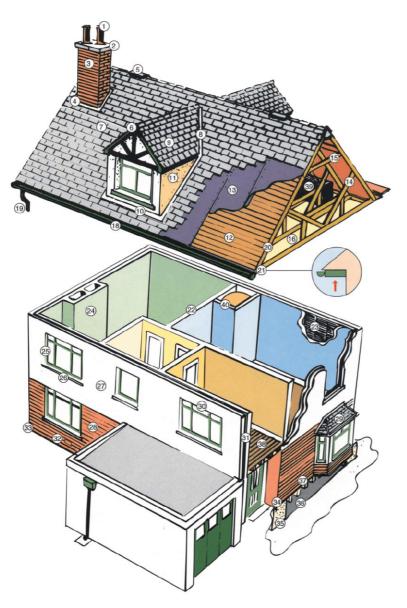
Sectional Diagram showing elements of a typical house

Reference may be made in this report to some or all of the above component parts of the property. This diagram may assist you in locating and understanding these items.
