Home Report

Scottish Single Survey

Property address	Borland House Kilmarnock KA3 6BW
-------------------------	--

Prepared by	Shepherd Chartered Surveyors
--------------------	------------------------------

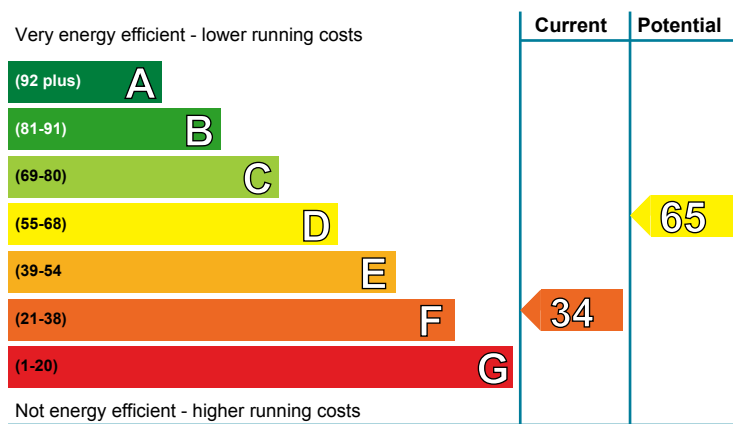
Energy Efficiency Rating

This graph shows the current efficiency of your home, taking into account both energy efficiency and fuel costs. The higher this rating, the lower your fuel bills are likely to be.

Your current rating is **band F (34)**. The average rating for EPCs in Scotland is **band D (61)**.

The potential rating shows the effect of undertaking all of the improvement measures listed within your recommendations report.

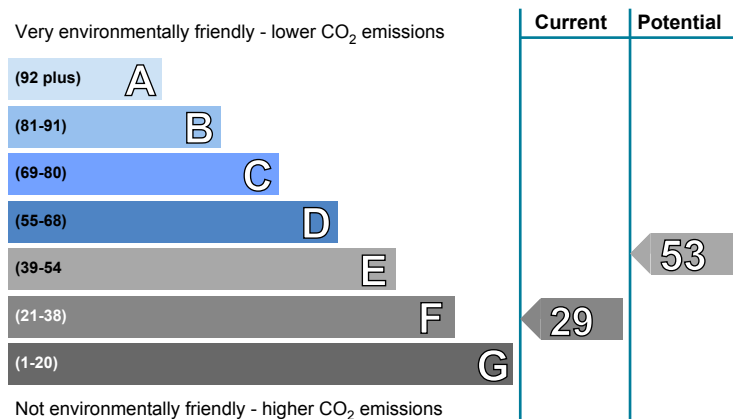
Environmental Impact (CO₂) Rating

This graph shows the effect of your home on the environment in terms of carbon dioxide (CO₂) emissions. The higher the rating, the less impact it has on the environment.
