HOME
report

SINGLE SURVEY
ENERGY REPORT
PROPERTY QUESTIONNAIRE
VALUATION REPORT

Property Address	Flat 2/2, 58 Gardner Street, Glasgow, G11 5BZ
Customer	Speedy Property Limited
Date of Inspection	13/01/2026
Prepared by	Brett G McMillan Harvey Donaldson & Gibson Chartered Surveyors

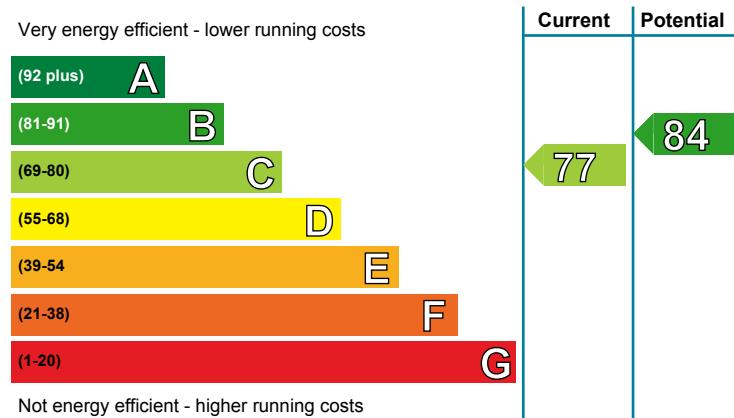
Energy Efficiency Rating

This graph shows the current efficiency of your home, taking into account both energy efficiency and fuel costs. The higher this rating, the lower your fuel bills are likely to be.

Your current rating is **band C (77)**. The average rating for EPCs in Scotland is **band D (61)**.

The potential rating shows the effect of undertaking all of the improvement measures listed within your recommendations report.

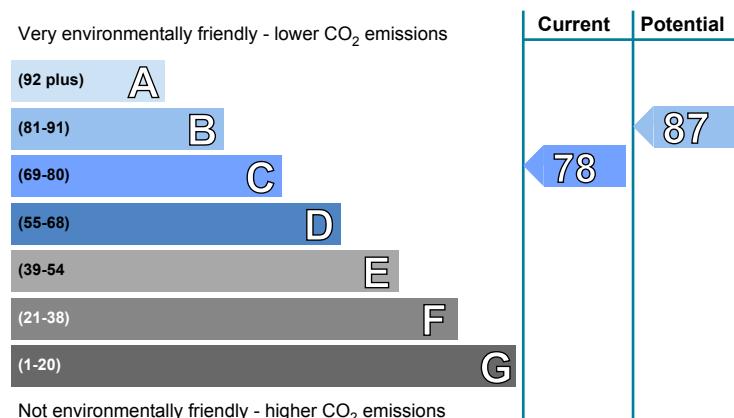
Environmental Impact (CO₂) Rating

This graph shows the effect of your home on the environment in terms of carbon dioxide (CO₂) emissions. The higher the rating, the less impact it has on the environment.
