HOME REPORT

Energy Performance Certificate (EPC)

85 DEE VILLAGE, MILLBURN STREET, ABERDEEN, AB11 6SZ

Single Survey

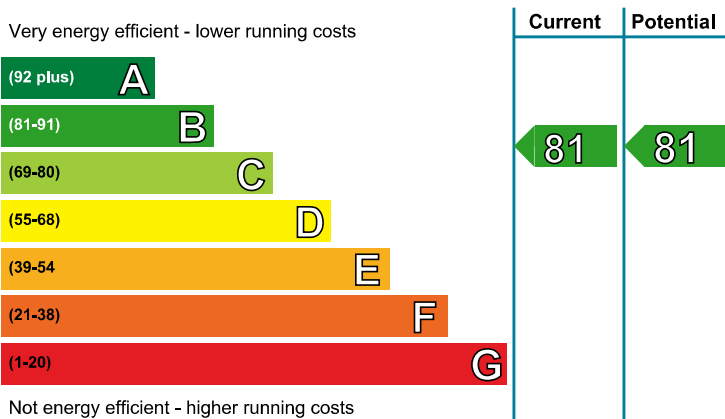
Energy Efficiency Rating

This graph shows the current efficiency of your home, taking into account both energy efficiency and fuel costs. The higher this rating, the lower your fuel bills are likely to be.

Your current rating is **band B (81)**. The average rating for EPCs in Scotland is **band D (61)**.

The potential rating shows the effect of undertaking all of the improvement measures listed within your recommendations report.

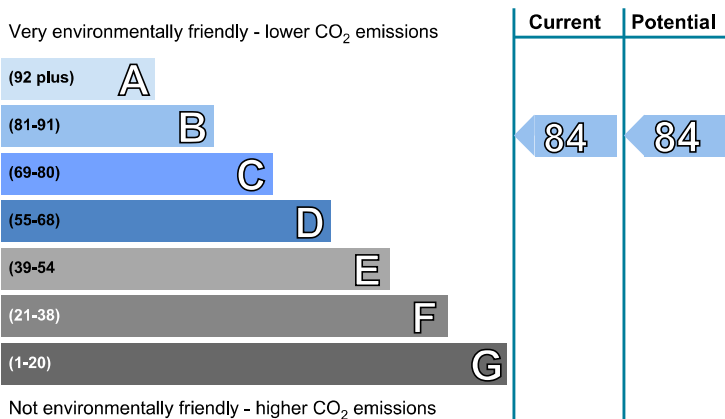
Environmental Impact (CO₂) Rating

This graph shows the effect of your home on the environment in terms of carbon dioxide (CO₂) emissions. The higher the rating, the less impact it has on the environment.

The potential rating shows the effect of undertaking all of the improvement measures listed within your recommendations report.

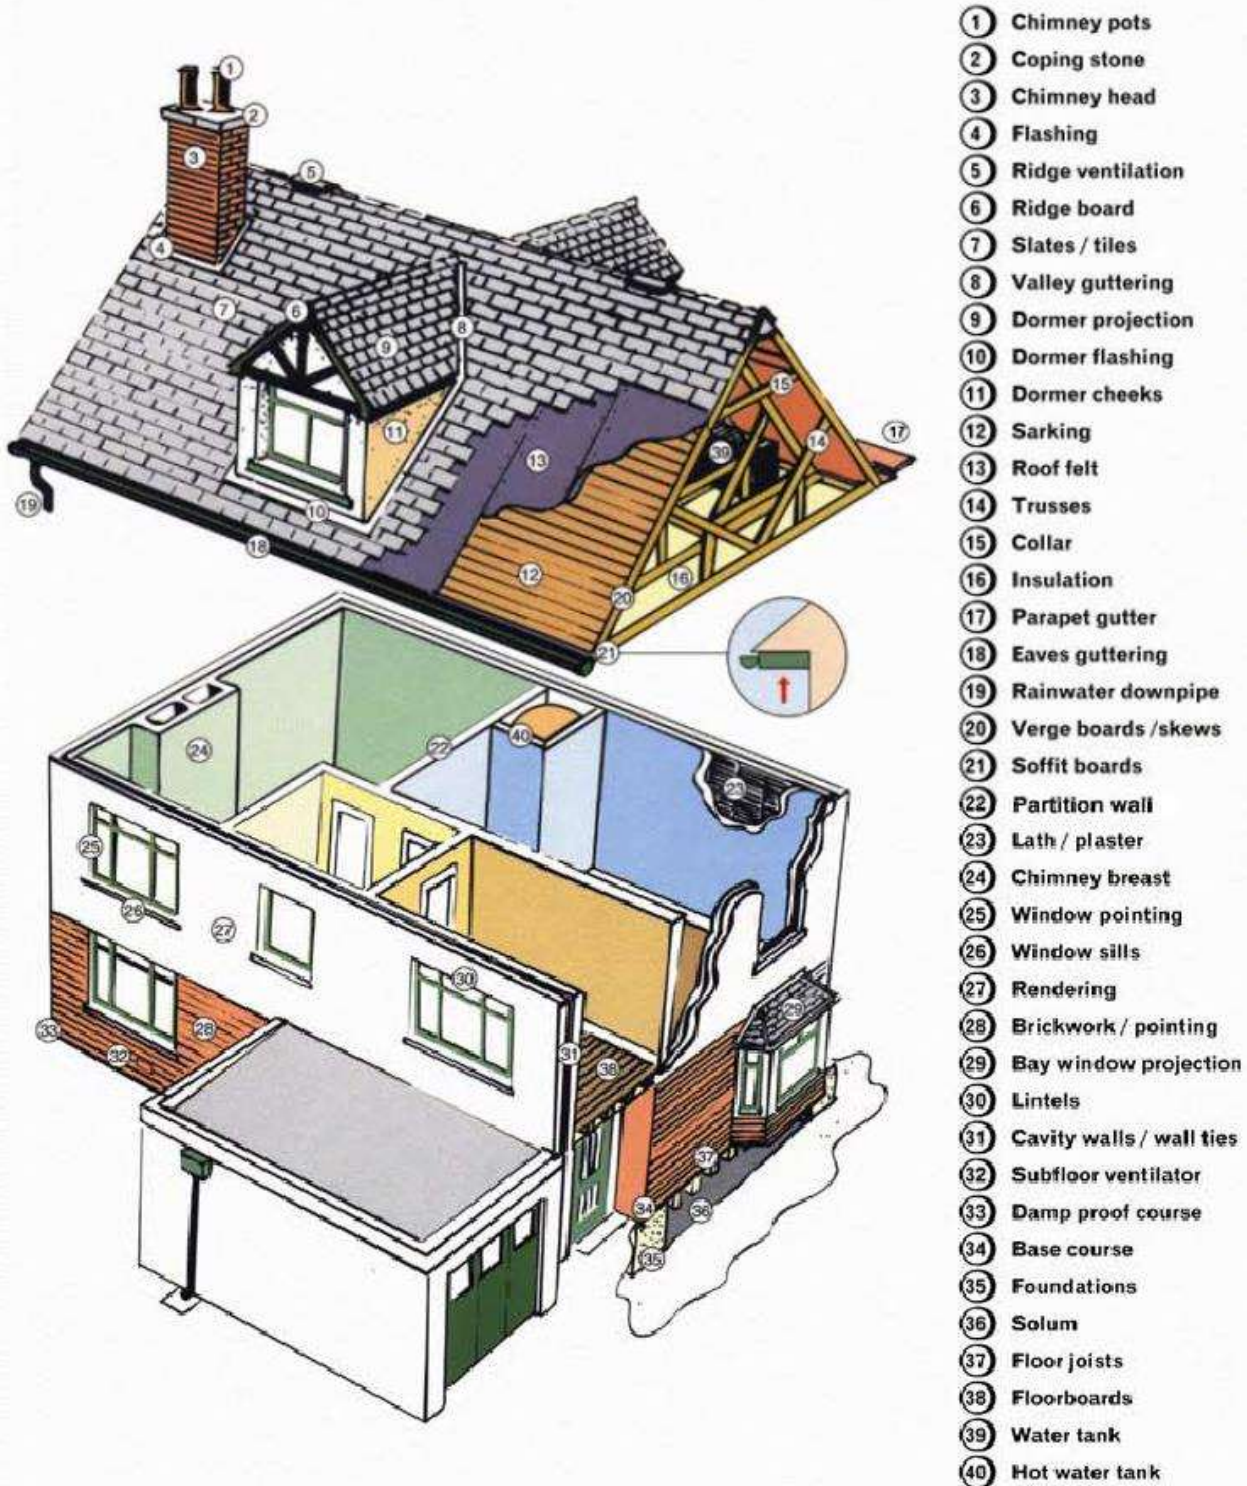
Sectional Diagram showing elements of a typical house

Reference may be made in this report to some or all of the above component parts of the property. This diagram may assist you in locating and understanding these items.
