# HOME REPORT

THE PIGEON LOFT KNOCKBREX

BORGUE  
KIRKCUDBRIGHT  
DG6 4UE

# Single Survey

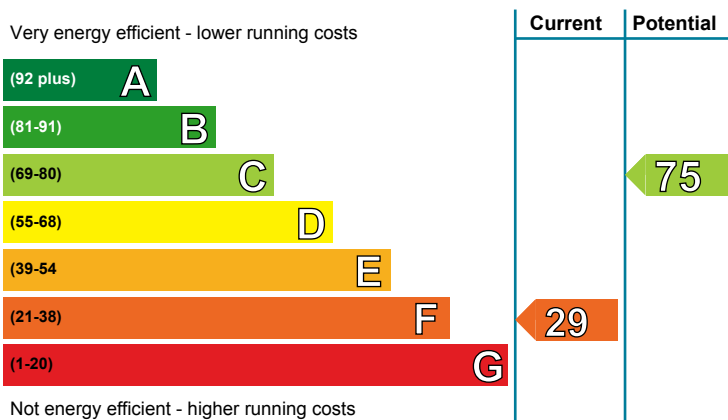
## Energy Efficiency Rating

This graph shows the current efficiency of your home, taking into account both energy efficiency and fuel costs. The higher this rating, the lower your fuel bills are likely to be.

Your current rating is **band F (29)**. The average rating for EPCs in Scotland is **band D (61)**.

The potential rating shows the effect of undertaking all of the improvement measures listed within your recommendations report.

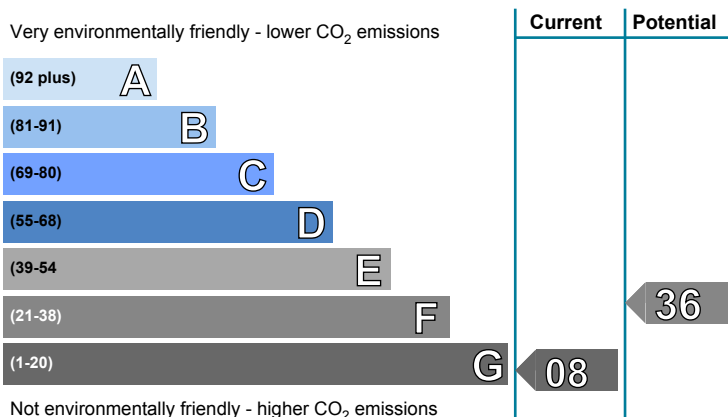
## Environmental Impact (CO<sub>2</sub>) Rating

This graph shows the effect of your home on the environment in terms of carbon dioxide (CO<sub>2</sub>) emissions. The higher the rating, the less impact it has on the environment.

Your current rating is **band G (8)**. The average rating for EPCs in Scotland is **band D (59)**.

The potential rating shows the effect of undertaking all of the improvement measures listed within your recommendations report.
