# Home Report

# Single Survey

| Property address | 54 Pleasance Avenue<br>Dumfries<br>DG2 7JL |
| Prepared by | Shepherd Chartered Surveyors |

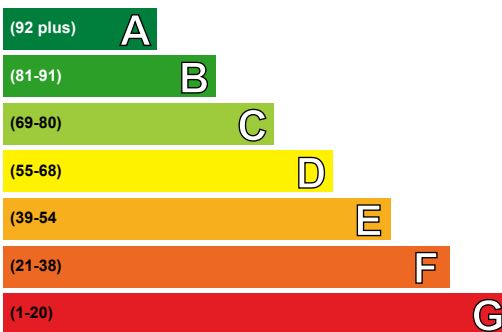
Very energy efficient - lower running costs

Not energy efficient - higher running costs

The potential rating shows the effect of undertaking all of the improvement measures listed within your recommendations report.
