Second Floor Left,  
5 Abbey Place,  
Aberdeen AB11 9QH

# Home Report

# Single Survey

## Survey Report on:

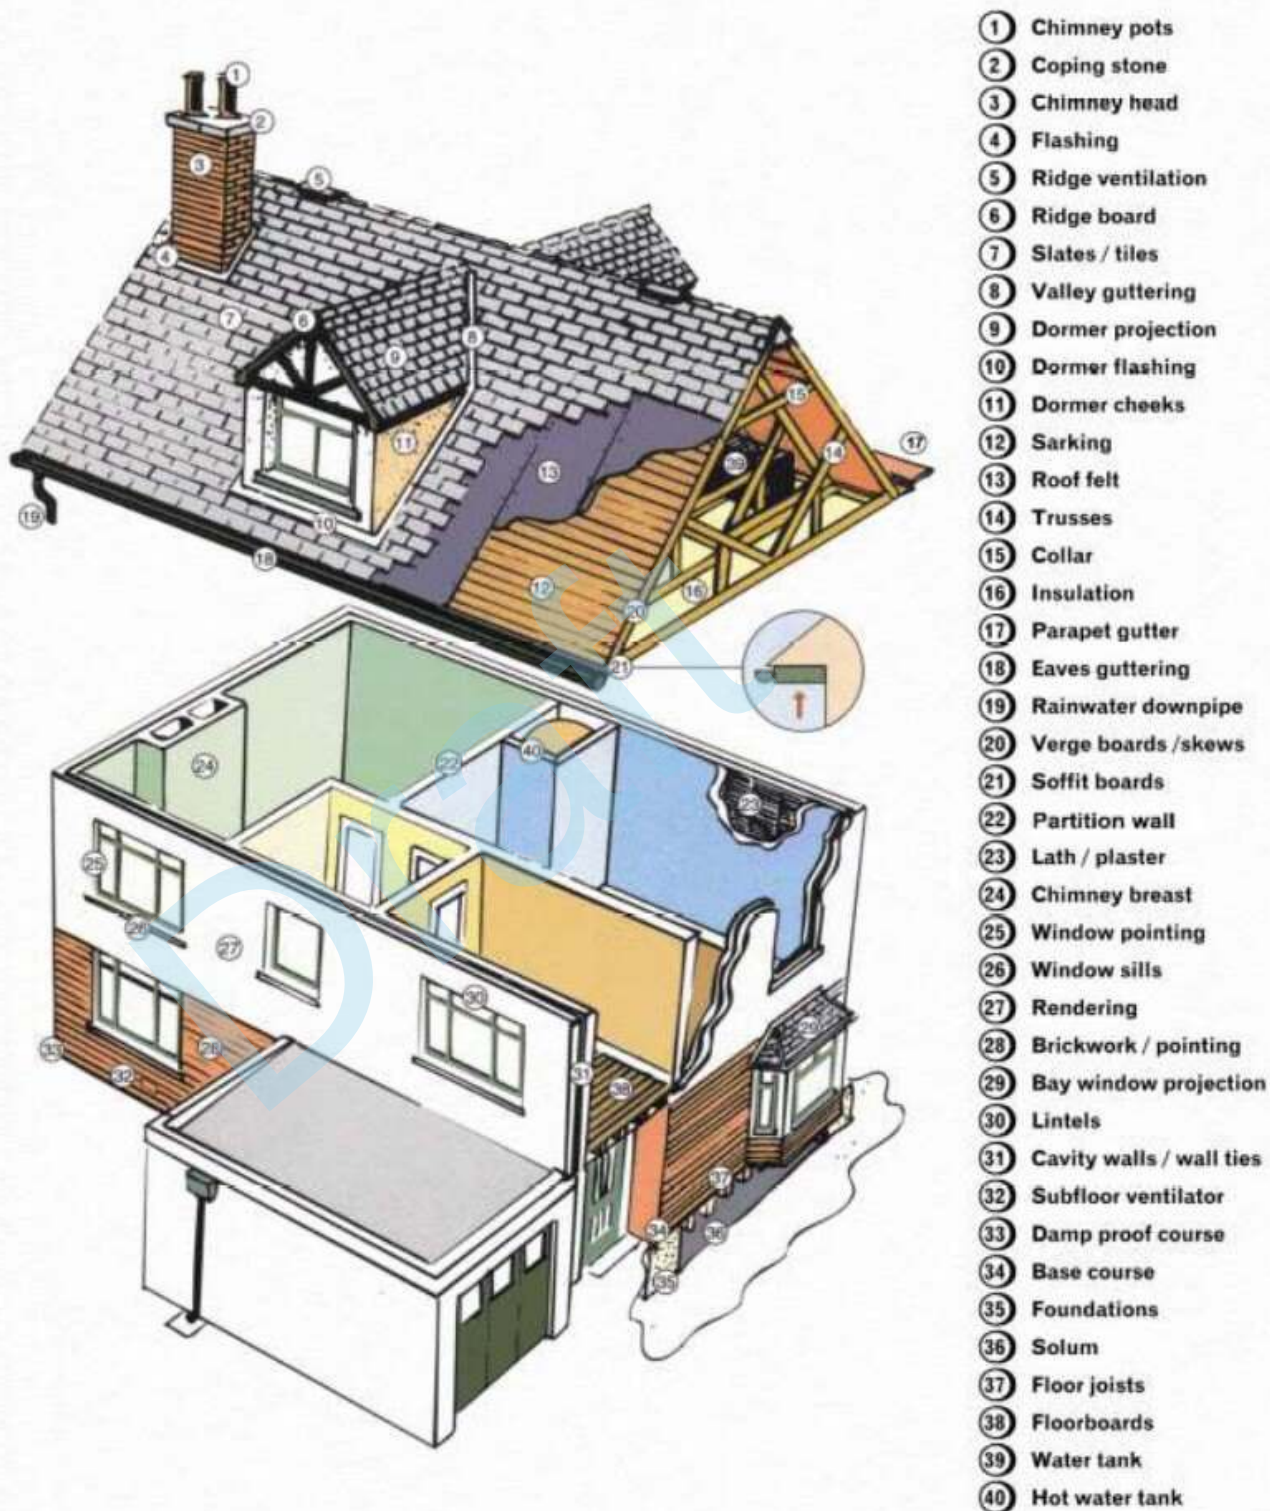
## Sectional Diagram showing elements of a typical house

Reference may be made in this report to some or all of the above component parts of the property. This diagram may assist you in locating and understanding these items.
