# Home Report

# Single Survey

## Survey Report on:

| <b>Property Address</b> | 11 Alvingham Avenue,<br>Castle Douglas,<br>Kirkcudbrightshire,<br>DG7 1JF |

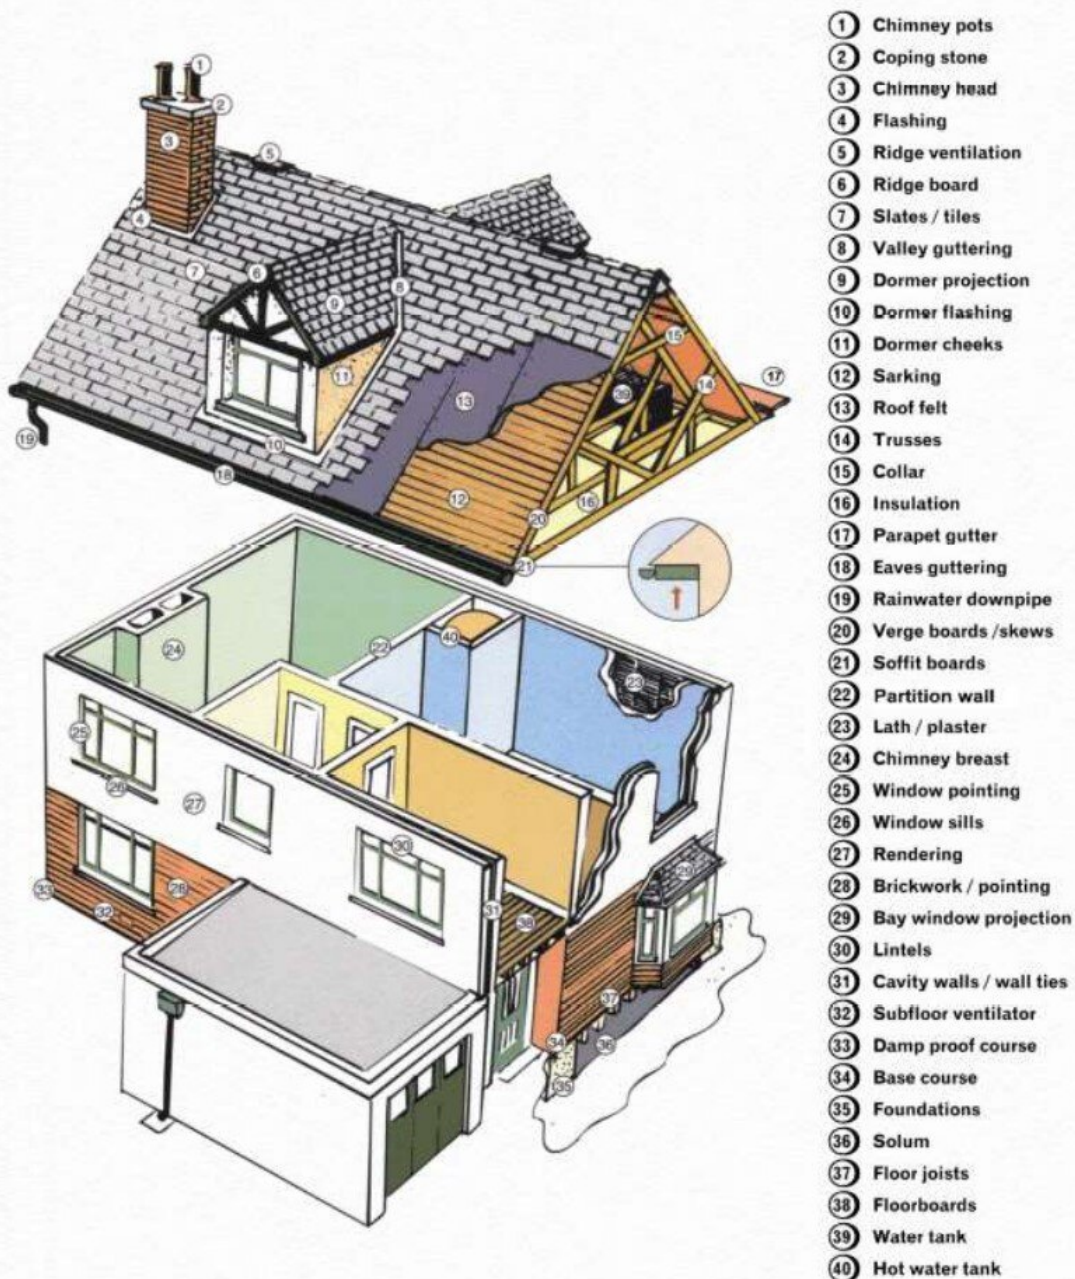
## Sectional Diagram showing elements of a typical house

Reference may be made in this report to some or all of the above component parts of the property. This diagram may assist you in locating and understanding these items.
