25 Main Street,
Dalry,
Castle Douglas,
Kirkcudbrightshire,
DG7 3UP

Home Report

Single Survey

Survey Report on:

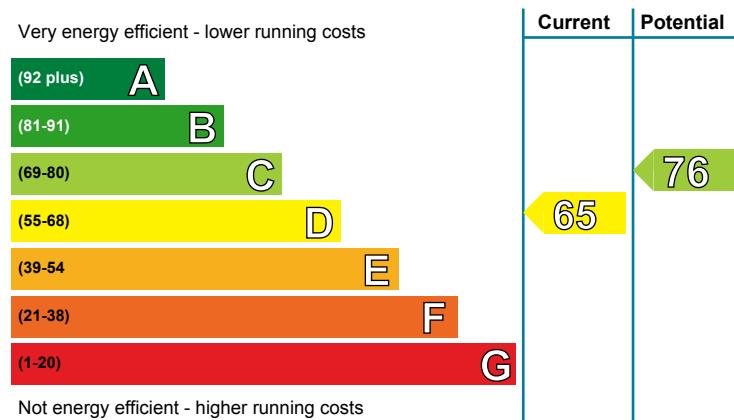
Energy Efficiency Rating

This graph shows the current efficiency of your home, taking into account both energy efficiency and fuel costs. The higher this rating, the lower your fuel bills are likely to be.

Your current rating is **band D (65)**. The average rating for EPCs in Scotland is **band D (61)**.

The potential rating shows the effect of undertaking all of the improvement measures listed within your recommendations report.

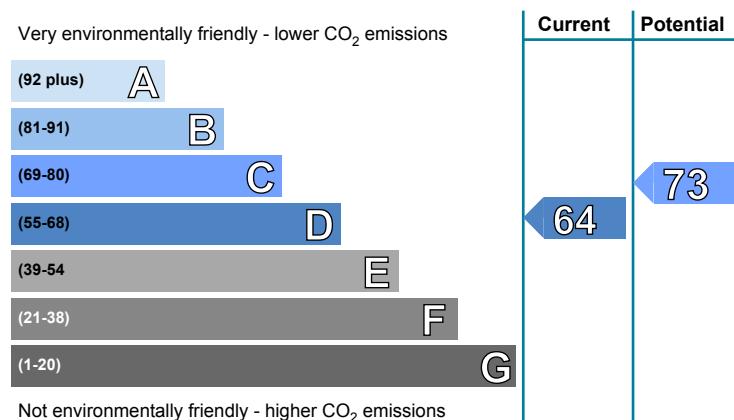
Environmental Impact (CO₂) Rating

This graph shows the effect of your home on the environment in terms of carbon dioxide (CO₂) emissions. The higher the rating, the less impact it has on the environment.
