Home Report

Single Survey

Property Address

4 Harbour Street,
Creetown,
Newton Stewart,
Wigtownshire,
DG8 7JJ

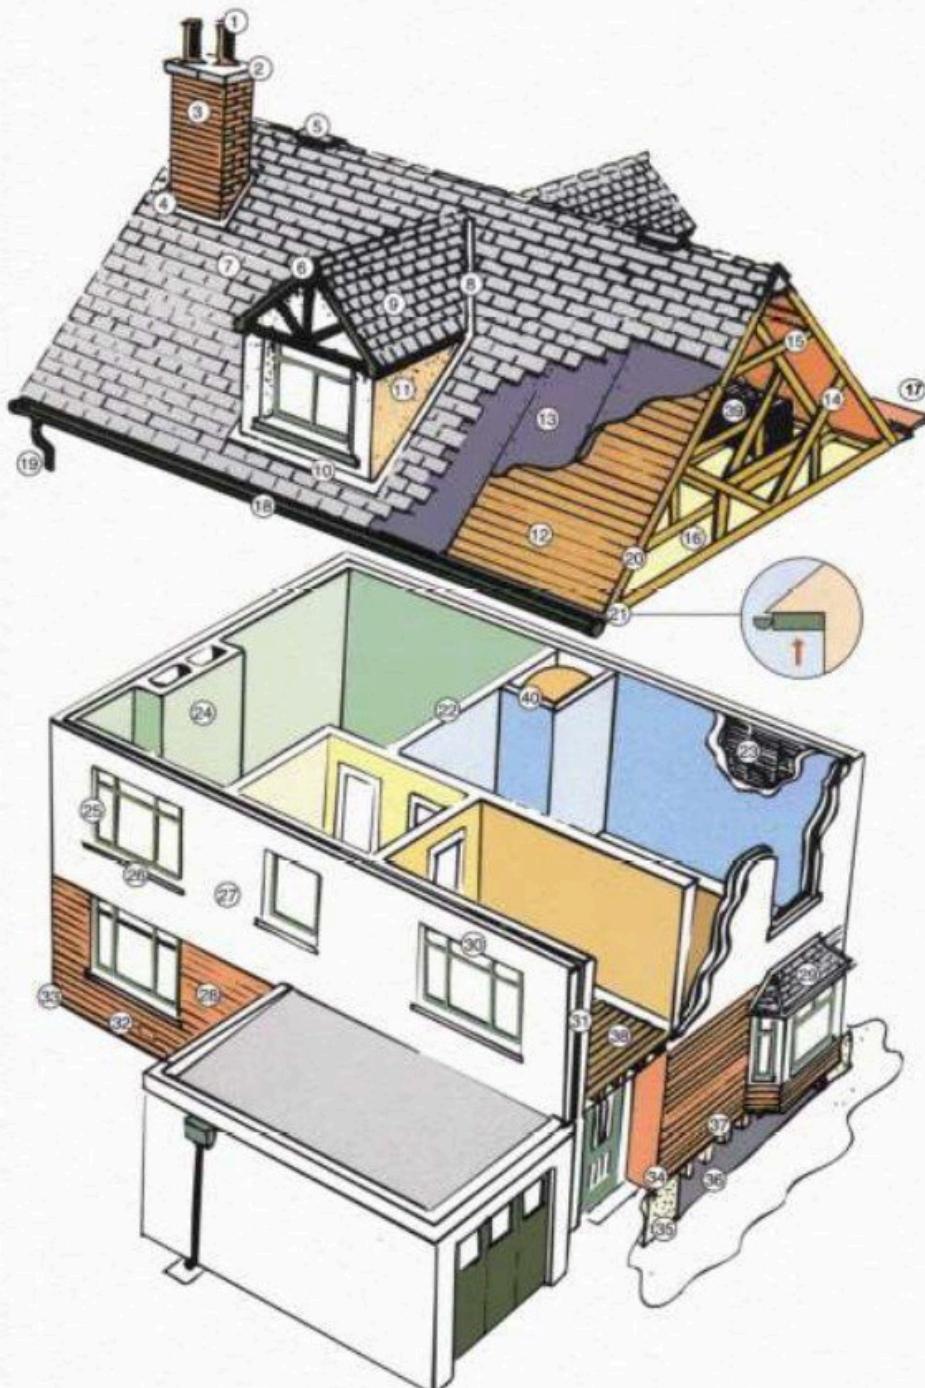
Sectional Diagram showing elements of a typical house

- 1 Chimney pots
- 2 Coping stone
- 3 Chimney head
- 4 Flashing
- 5 Ridge ventilation
- 6 Ridge board
- 7 Slates / tiles
- 8 Valley guttering
- 9 Dormer projection
- 10 Dormer flashing
- 11 Dormer cheeks
- 12 Sarking
- 13 Roof felt
- 14 Trusses
- 15 Collar
- 16 Insulation
- 17 Parapet gutter
- 18 Eaves guttering
- 19 Rainwater downpipe
- 20 Verge boards / skewers
- 21 Soffit boards
- 22 Partition wall
- 23 Lath / plaster
- 24 Chimney breast
- 25 Window pointing
- 26 Window sills
- 27 Rendering
- 28 Brickwork / pointing
- 29 Bay window projection
- 30 Lintels
- 31 Cavity walls / wall ties
- 32 Subfloor ventilator
- 33 Damp proof course
- 34 Base course
- 35 Foundations
- 36 Solum
- 37 Floor joists
- 38 Floorboards
- 39 Water tank
- 40 Hot water tank

Reference may be made in this report to some or all of the above component parts of the property. This diagram may assist you in locating and understanding these items.

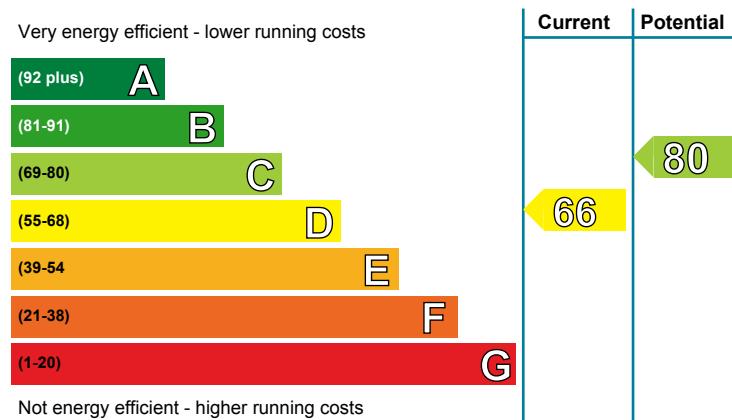
Energy Efficiency Rating

This graph shows the current efficiency of your home, taking into account both energy efficiency and fuel costs. The higher this rating, the lower your fuel bills are likely to be.

Your current rating is **band D (66)**. The average rating for EPCs in Scotland is **band D (61)**.

The potential rating shows the effect of undertaking all of the improvement measures listed within your recommendations report.

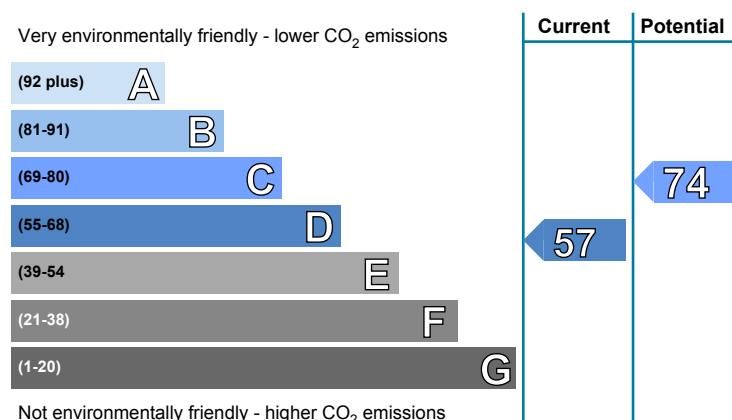
Environmental Impact (CO₂) Rating

This graph shows the effect of your home on the environment in terms of carbon dioxide (CO₂) emissions. The higher the rating, the less impact it has on the environment.
