HOME REPORT

9 KIRKHILL
WICK
KW1 4DD

Energy Performance Certificate (EPC)

9 KIRK HILL, WICK, KW1 4DD

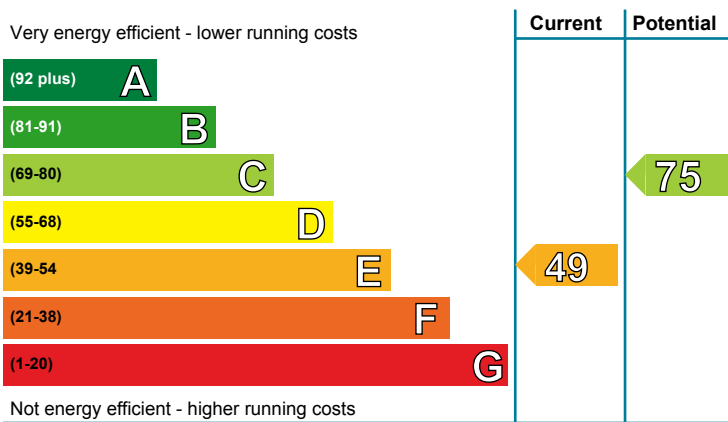
Energy Efficiency Rating

This graph shows the current efficiency of your home, taking into account both energy efficiency and fuel costs. The higher this rating, the lower your fuel bills are likely to be.

Your current rating is **band E (49)**. The average rating for EPCs in Scotland is **band D (61)**.

The potential rating shows the effect of undertaking all of the improvement measures listed within your recommendations report.

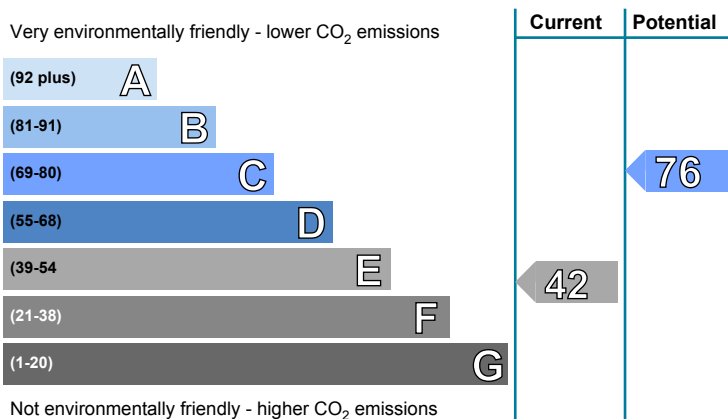
Environmental Impact (CO₂) Rating

This graph shows the effect of your home on the environment in terms of carbon dioxide (CO₂) emissions. The higher the rating, the less impact it has on the environment.

Your current rating is **band E (42)**. The average rating for EPCs in Scotland is **band D (59)**.

The potential rating shows the effect of undertaking all of the improvement measures listed within your recommendations report.
