HOME REPORT

FLAT
1 NAVER HOUSE
NAVER ROAD, PENNYLAND
THURSO
KW14 7QA

Energy Performance Certificate (EPC)

FLAT 1 NAVER HOUSE, NAVER ROAD, PENNYLAND, THURSO, KW14 7QA

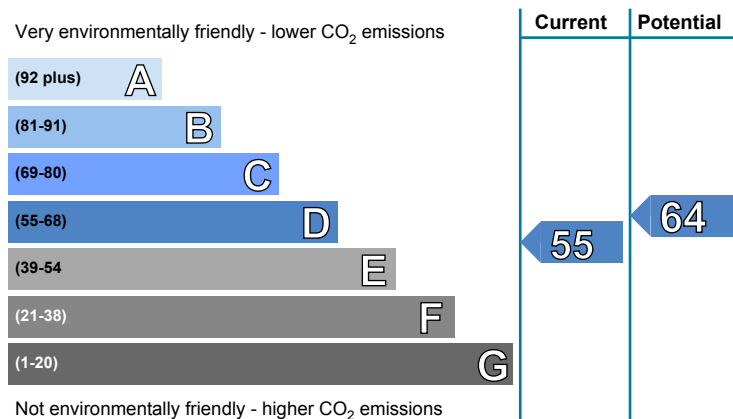
Environmental Impact (CO₂) Rating

This graph shows the effect of your home on the environment in terms of carbon dioxide (CO₂) emissions. The higher the rating, the less impact it has on the environment.

Your current rating is **band D (55)**. The average rating for EPCs in Scotland is **band D (59)**.

The potential rating shows the effect of undertaking all of the improvement measures listed within your recommendations report.
