# **Single Survey**

32 Harrow Terrace Wick KW1 5BS

### survey report on:

Customer	Graeme Sinclair
Customer Address	70 Henrietta Street Wick KW1 4HE
Date of Inspection	9 <sup>th</sup> November 2023
Prepared by	Angus Macaulay BSc MRICS Registered Valuer

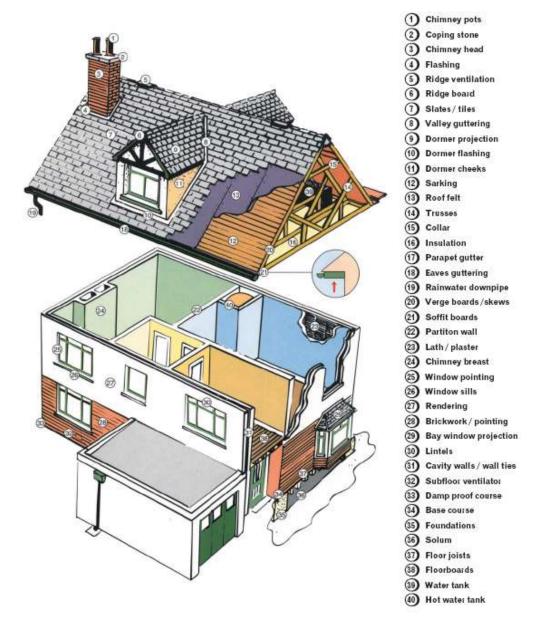
### Sectional Diagram showing elements of a typical house

Reference may be made in this report to some or all of the above component parts of the property. This diagram may assist you in locating and understanding these items.
