Single Survey

Kelvindale 1 Coronation Street Wick KW1 5LS

survey report on :

Customer	Dr Anne and Mr Ewan Brown
Customer Address	
Date of Inspection	4 th October 2022
Prepared by	Keith J Bowman BSc MRICS Registered Valuer

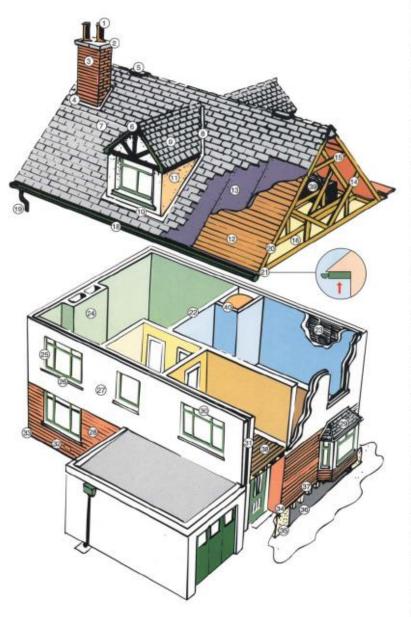
Sectional Diagram showing elements of a typical house

Reference may be made in this report to some or all of the above component parts of the property. This diagram may assist you in locating and understanding these items.
