# HOME REPORT

HAWTHORN COTTAGE

LATHERON  
KW5 6DL

**Dwelling type:** Detached bungalow  
**Date of assessment:** 17 March 2023  
**Date of certificate:** 23 March 2023  
**Total floor area:** 72 m<sup>2</sup>  
**Primary Energy Indicator:** 802 kWh/m<sup>2</sup>/year

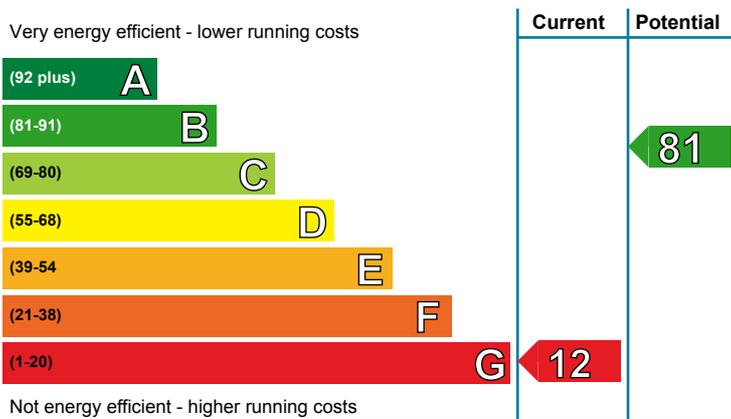
## Energy Efficiency Rating

This graph shows the current efficiency of your home, taking into account both energy efficiency and fuel costs. The higher this rating, the lower your fuel bills are likely to be.

Your current rating is **band G (12)**. The average rating for EPCs in Scotland is **band D (61)**.

The potential rating shows the effect of undertaking all of the improvement measures listed within your recommendations report.

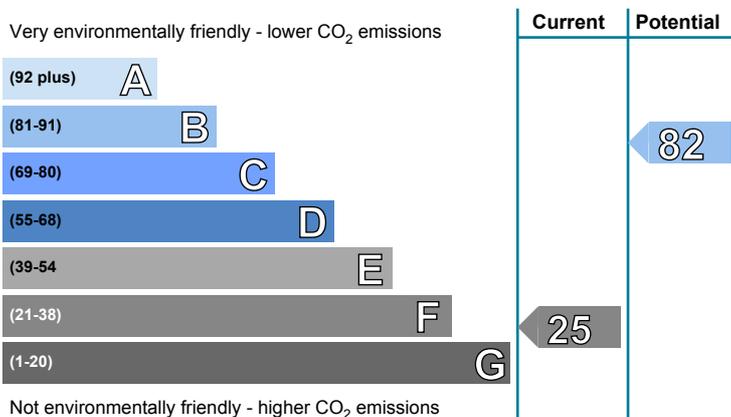
## Environmental Impact (CO<sub>2</sub>) Rating

This graph shows the effect of your home on the environment in terms of carbon dioxide (CO<sub>2</sub>) emissions. The higher the rating, the less impact it has on the environment.

Your current rating is **band F (25)**. The average rating for EPCs in Scotland is **band D (59)**.

The potential rating shows the effect of undertaking all of the improvement measures listed within your recommendations report.
