HOME REPORT

MOUNT HOOLY HOUSE
9 SHORE LANE
WICK
KW1 4NT

Energy Performance Certificate (EPC)

MOUNT HOOLY HOUSE, 9 SHORE LANE, WICK, KW1 4NT

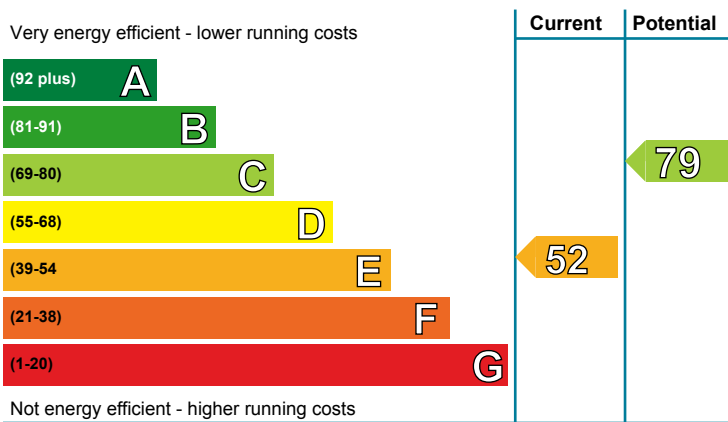
Energy Efficiency Rating

This graph shows the current efficiency of your home, taking into account both energy efficiency and fuel costs. The higher this rating, the lower your fuel bills are likely to be.

Your current rating is **band E (52)**. The average rating for EPCs in Scotland is **band D (61)**.

The potential rating shows the effect of undertaking all of the improvement measures listed within your recommendations report.

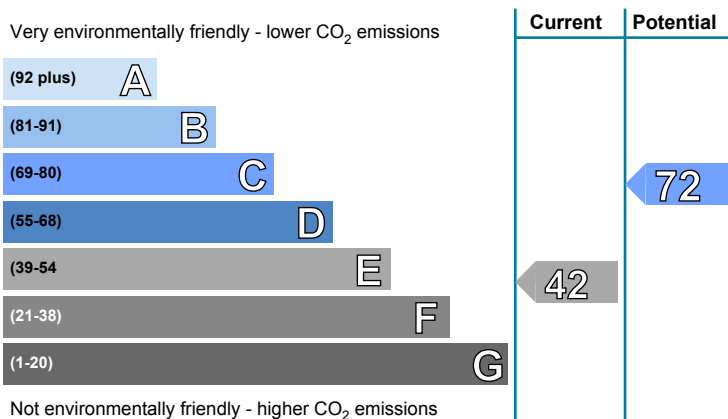
Environmental Impact (CO₂) Rating

This graph shows the effect of your home on the environment in terms of carbon dioxide (CO₂) emissions. The higher the rating, the less impact it has on the environment.

Your current rating is **band E (42)**. The average rating for EPCs in Scotland is **band D (59)**.

The potential rating shows the effect of undertaking all of the improvement measures listed within your recommendations report.
