HOME REPORT

GREEN BRAES SOUTH STREET

KEISS
WICK
KW1 4XE

Energy Performance Certificate (EPC)

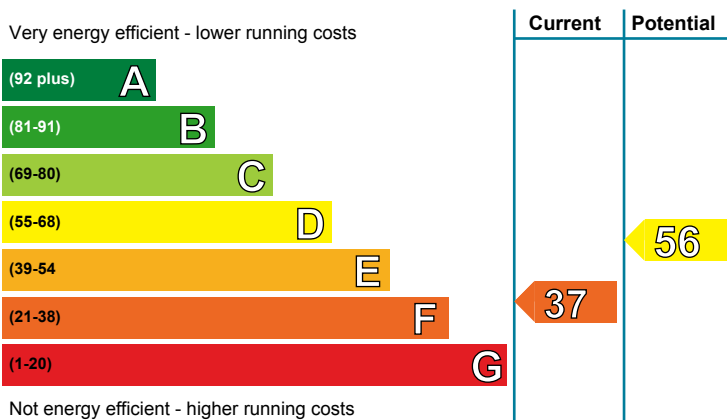
Energy Efficiency Rating

This graph shows the current efficiency of your home, taking into account both energy efficiency and fuel costs. The higher this rating, the lower your fuel bills are likely to be.

Your current rating is **band F (37)**. The average rating for EPCs in Scotland is **band D (61)**.

The potential rating shows the effect of undertaking all of the improvement measures listed within your recommendations report.

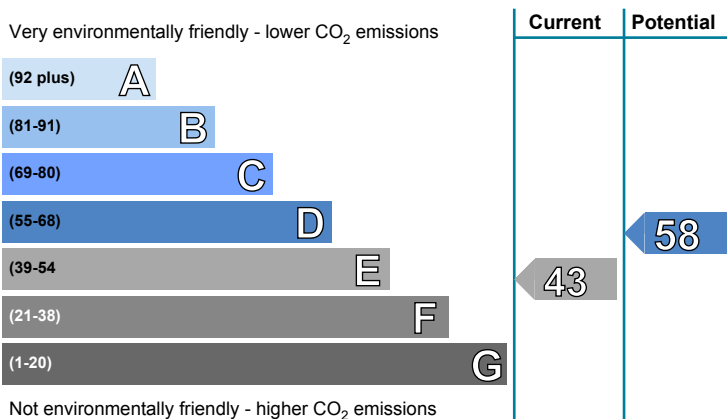
Environmental Impact (CO₂) Rating

This graph shows the effect of your home on the environment in terms of carbon dioxide (CO₂) emissions. The higher the rating, the less impact it has on the environment.

Your current rating is **band E (43)**. The average rating for EPCs in Scotland is **band D (59)**.

The potential rating shows the effect of undertaking all of the improvement measures listed within your recommendations report.
