Home Report

2 Bruce Buildings High Street Falkland Cupar KY15 7BL

single survey

survey report on:

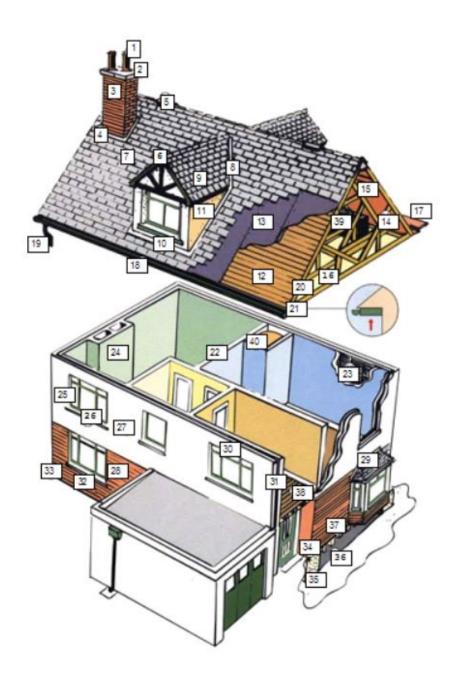
Sectional Diagram showing elements of a typical house

Chimney pots

2 Coping stone

35 Foundations
