# Home Report

24 Forth House Abbotshall Road  
Kirkcaldy KY1 1AN

# single survey

<b>Property address</b>	24 Forth House Abbotshall Road Kirkcaldy KY1 1AN
-------------------------	---

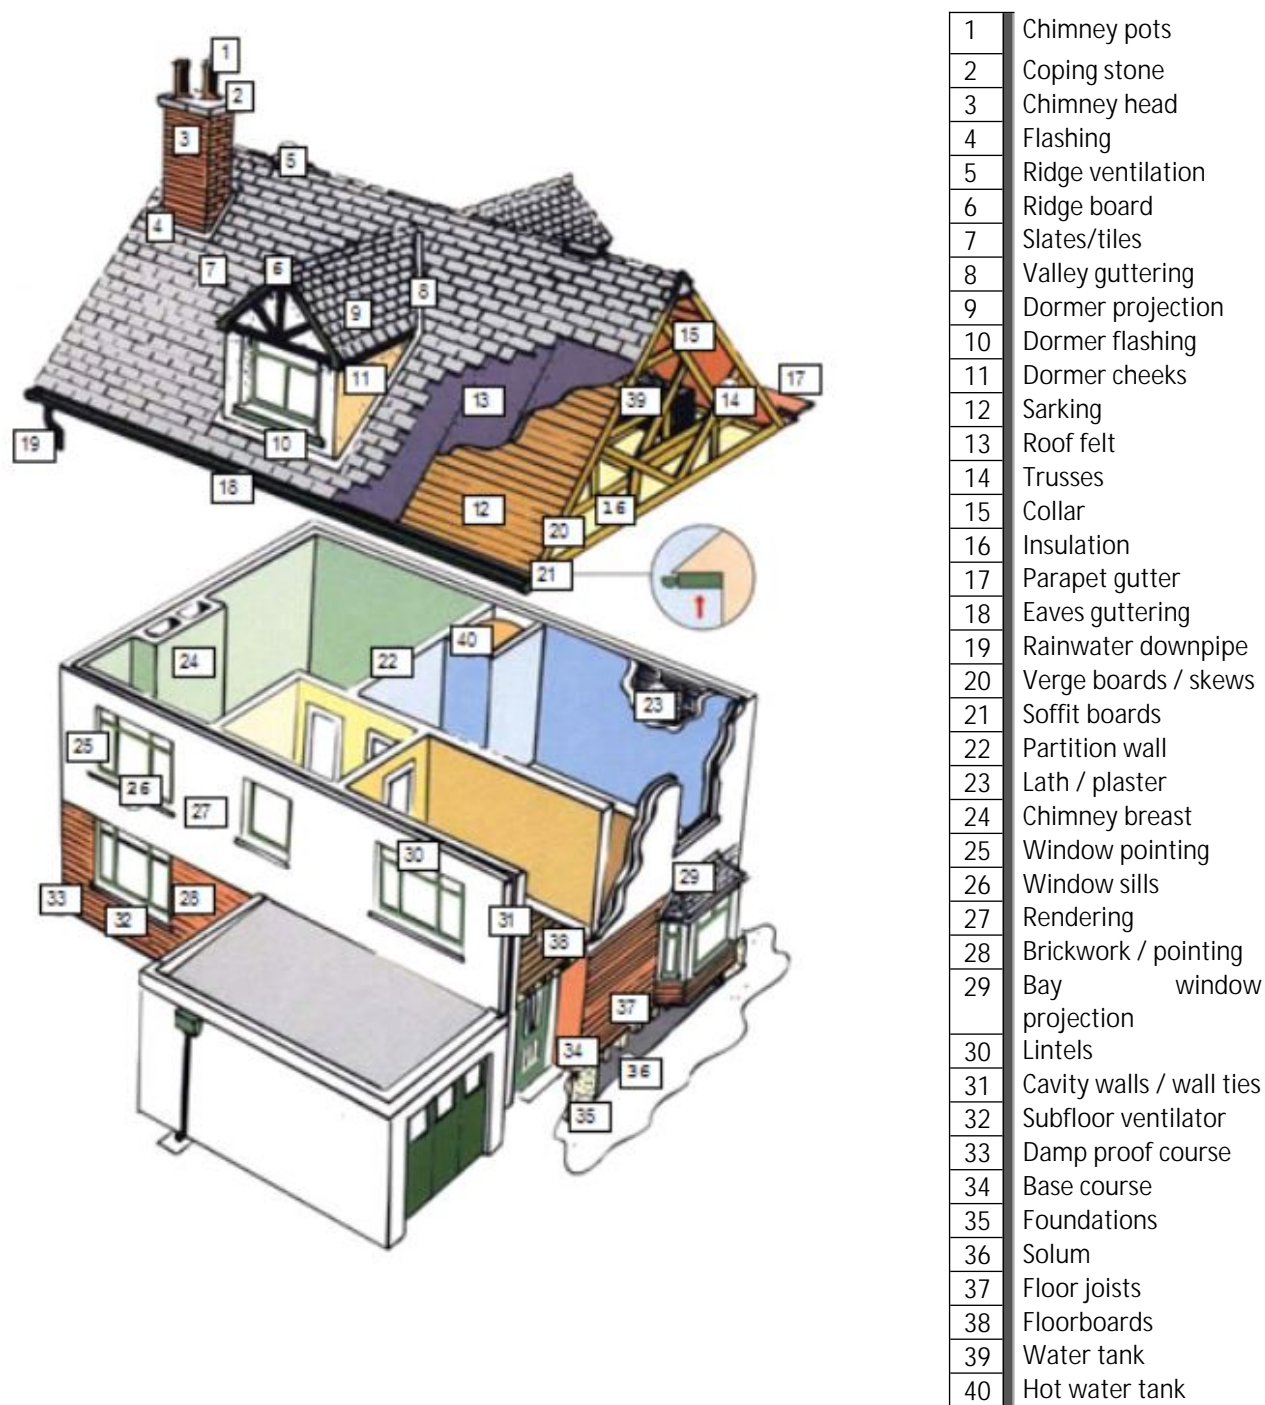
# Sectional Diagram showing elements of a typical house

Reference may be made in this report to some or all of the above component parts of the property. This diagram may assist you in locating and understanding these items.
