Home Report

17 Dallas Drive Kirkcaldy KY2 6NE

Single Survey

Property Address	17 Dallas Drive Kirkcaldy KY2 6NE
Customer	Warren Ho
Prepared by	Graham + Sibbald LLP
Date of Inspection	04/03/2025

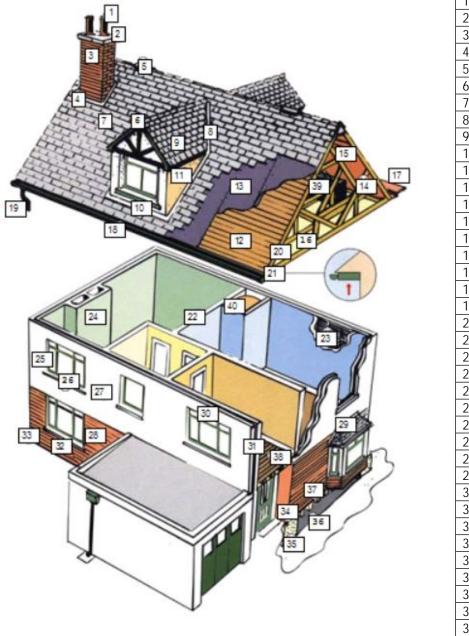
Sectional diagram showing elements of a typical house

_
1	Chimney pots
2	Coping stone
3	Chimney head
4	Flashing
5	Ridge ventilation
6	Ridge board
7	Slates / tiles
8	Valley guttering
9	Dormer projection
10	Dormer flashing
11	Dormer cheeks
12	Sarking
13	Roof felt
14	Trusses
15	Collar
16	Insulation
17	Parapet gutter
18	Eaves guttering
19	Rainwater downpipe
20	Verge boards / skews
21	Soffit boards
22	Partition wall
23	Lath / plaster
24	Chimney breast
25	Window pointing
26	Window sills
27	Rendering
28	Brickwork / pointing
29	Bay window projection
30	Lintels
31	Cavity walls / wall ties
32	Subfloor ventilator
33	Damp proof course
34	Base course
35	Foundations
36	Solum
37	Floor joists
38	Floorboards
39	Water tank
40	Hot water tank

Reference may be made in this report to some or all of the above component parts of the property. This diagram may assist you in locating and understanding these items.
