# Home Report

47 Raith Drive  
Kirkcaldy KY2 5NS

# Single Survey

| <b>Description</b> | The subjects comprise a two storey detached house. |

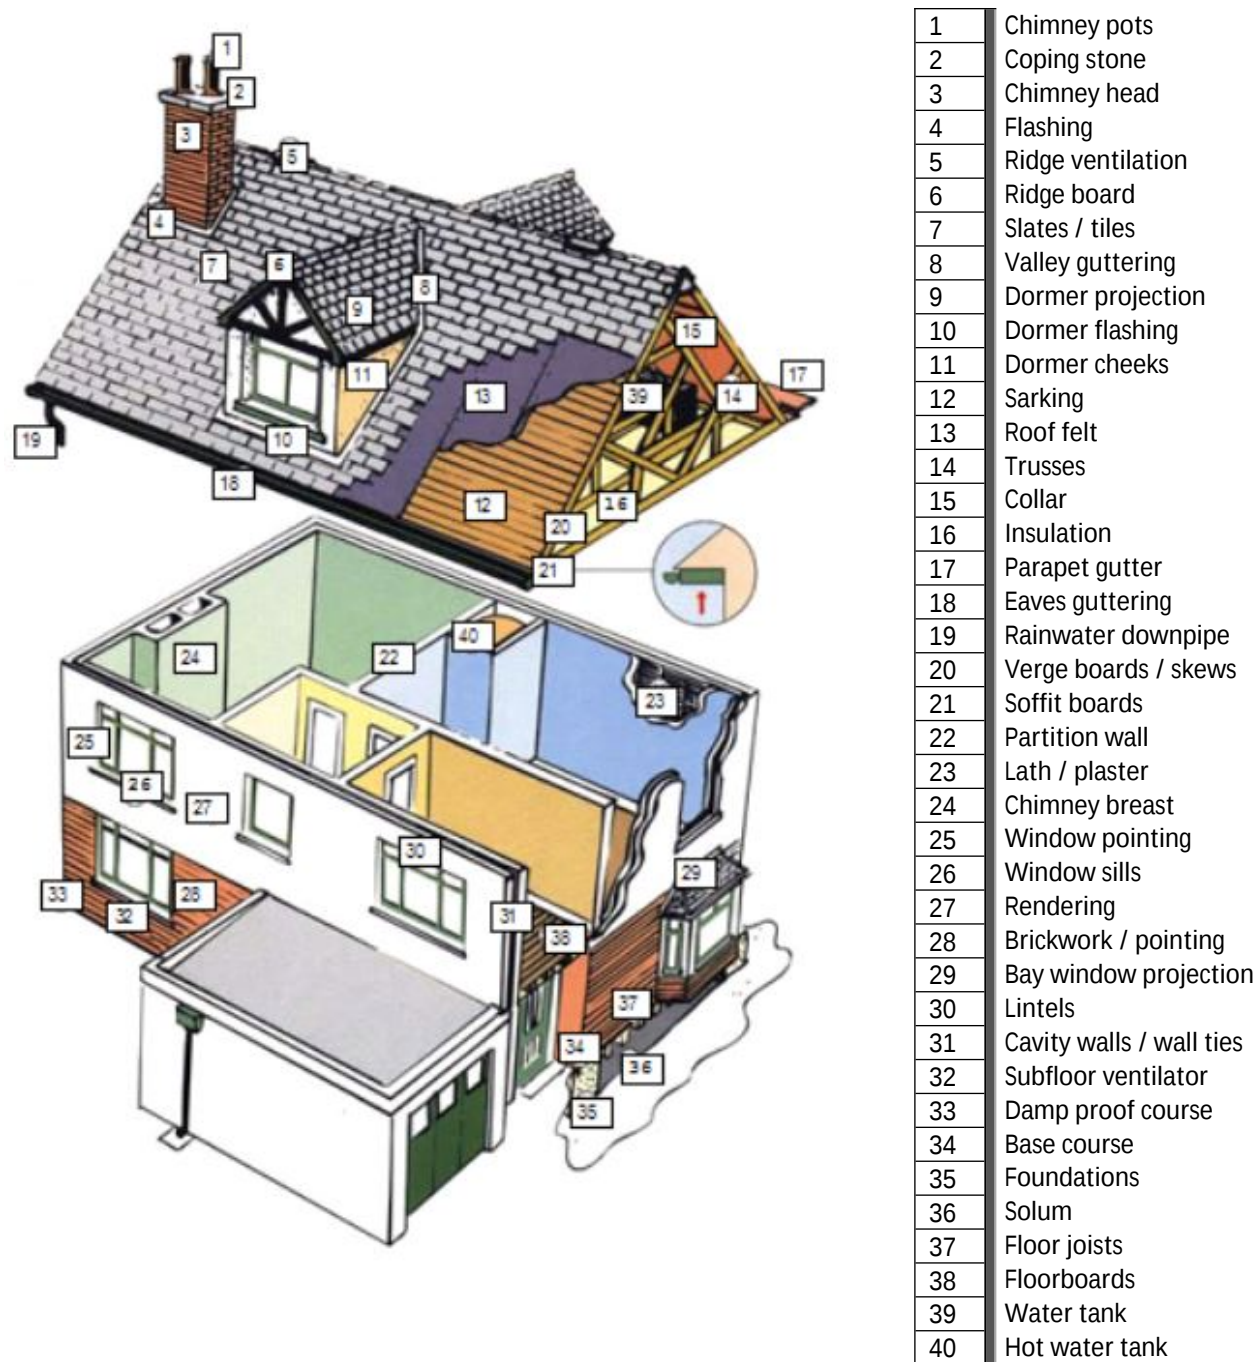
# Sectional diagram showing elements of a typical house

Reference may be made in this report to some or all of the above component parts of the property. This diagram may assist you in locating and understanding these items.

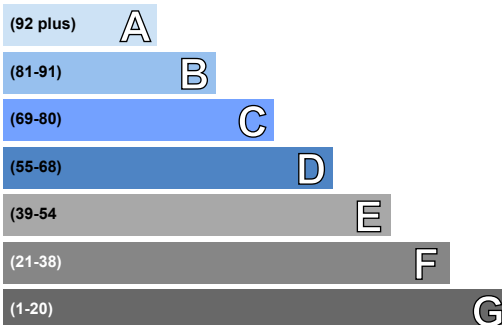
Very environmentally friendly - lower CO<sub>2</sub> emissions

Not environmentally friendly - higher CO<sub>2</sub> emissions
