# Home Report

8 Stanley Park, Townsend Crescent  
Kirkcaldy KY1 1DP

# Single Survey

| Property Address | 8 Stanley Park, Townsend Crescent<br>Kirkcaldy<br>KY1 1DP |

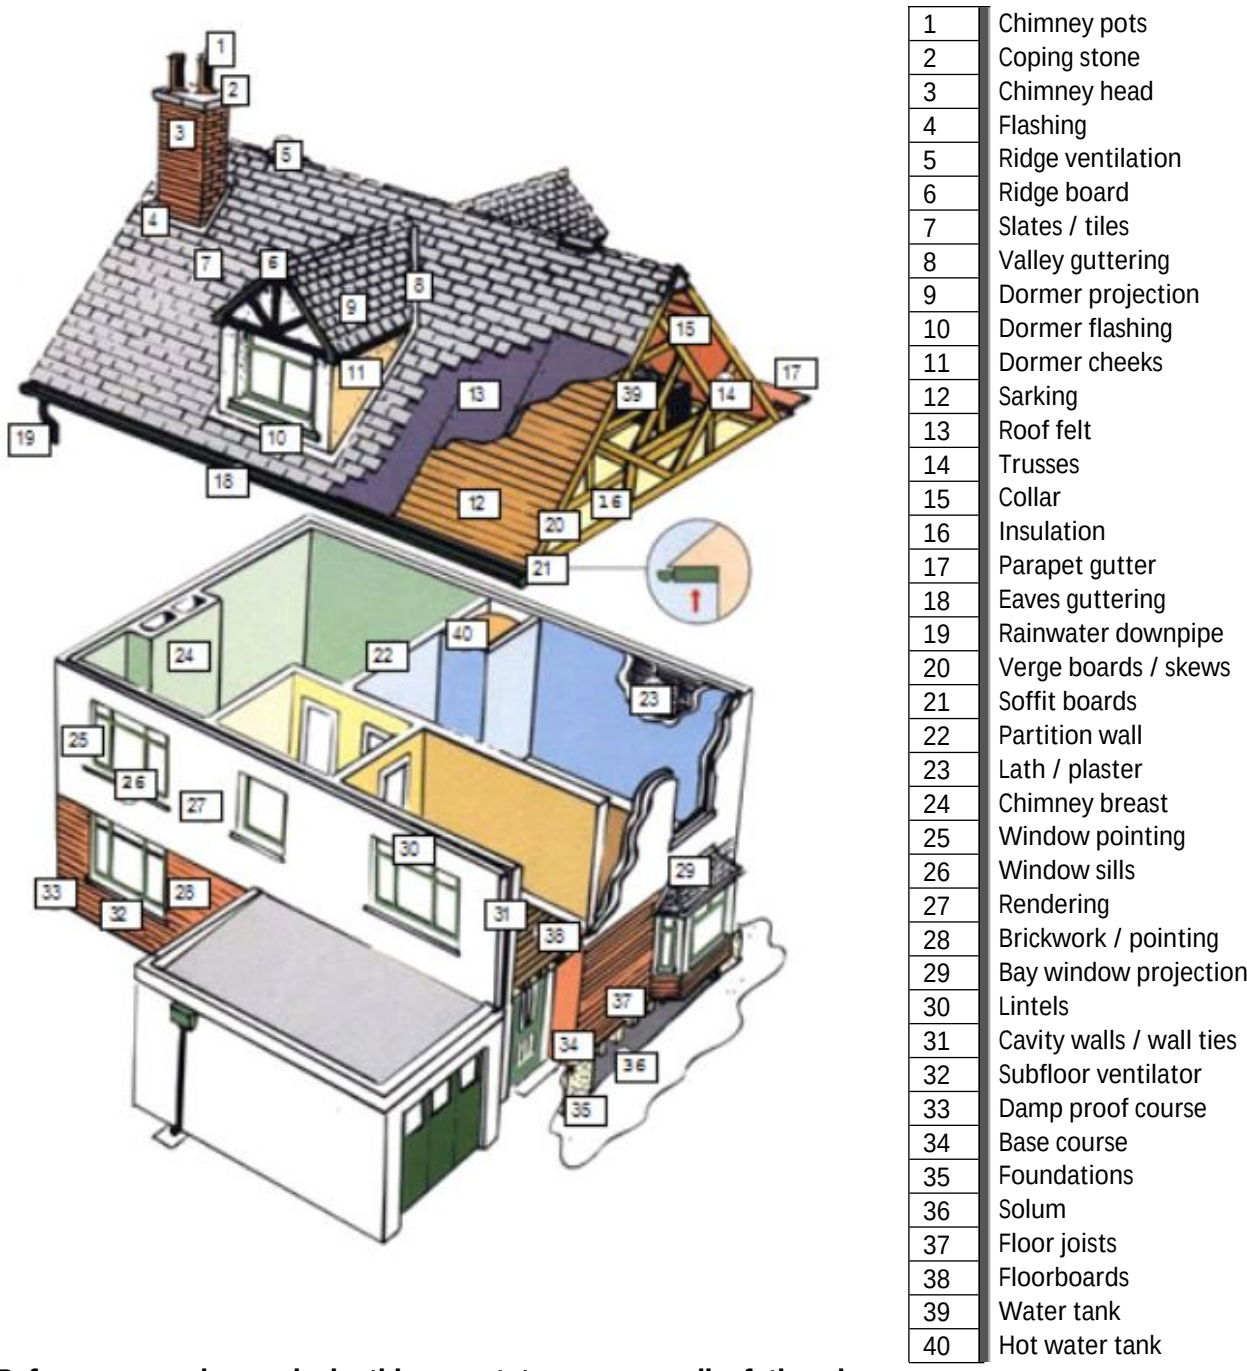
# Sectional diagram showing elements of a typical house

Reference may be made in this report to some or all of the above component parts of the property. This diagram may assist you in locating and understanding these items.
