Survey Report On

> Ballasquoy, Evie, Orkney, KW17 2PF.

Date of inspection: 11th March 2025.

Prepared by: Christopher Park, M.R.I.C.S.,

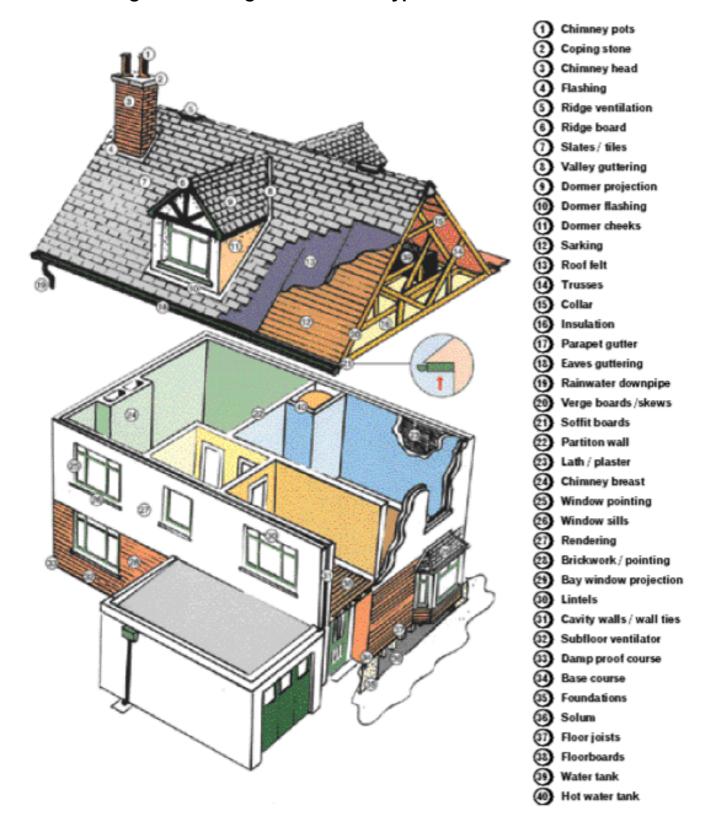
Sectional diagram showing elements of a typical house

Reference may be made in this report to some or all of the above component parts of the property. This diagram may assist you in locating and understanding these terms.
