# Single Survey

| Property address | 35 GREAT SOUTHERN ROAD<br>ABERDEEN<br>AB11 7XY |
| Prepared by | Graham & Sibbald |
| Date of inspection | 7th June 2023 |

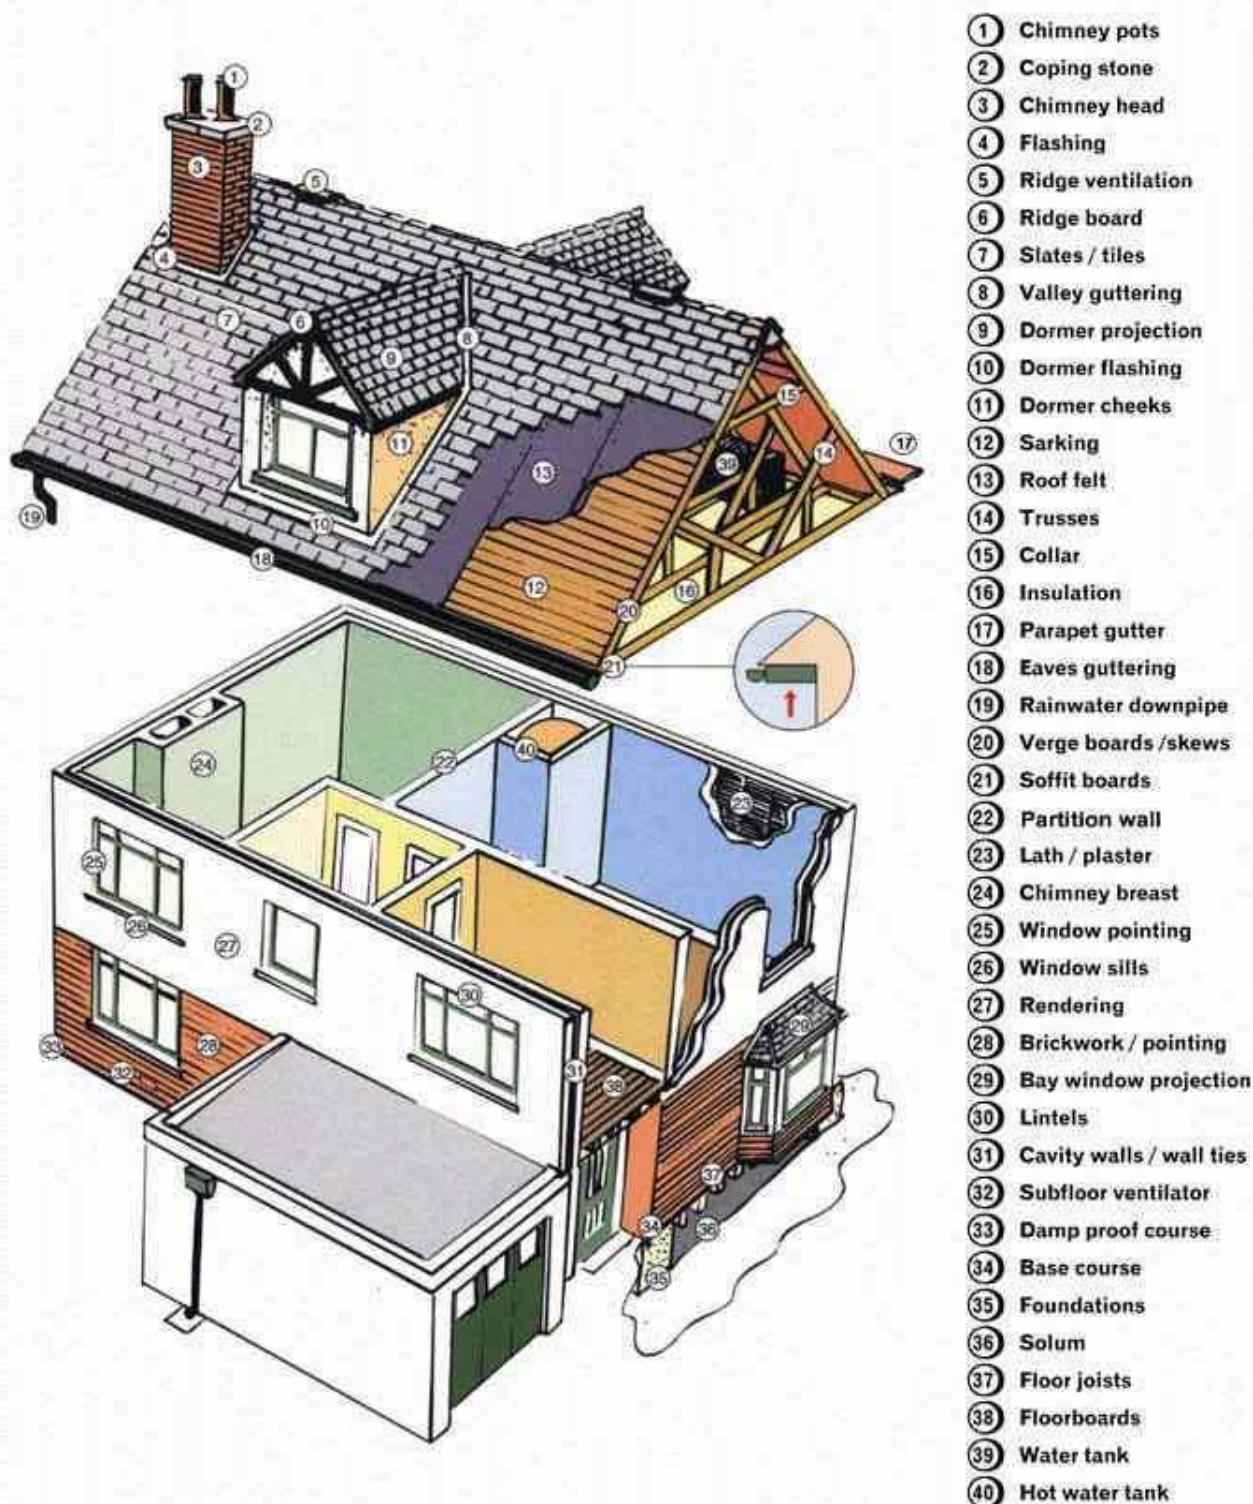
## Sectional Diagram showing elements of a typical house

Reference may be made in this report to some or all of the above component parts of the property. This diagram may assist you in locating and understanding these items.

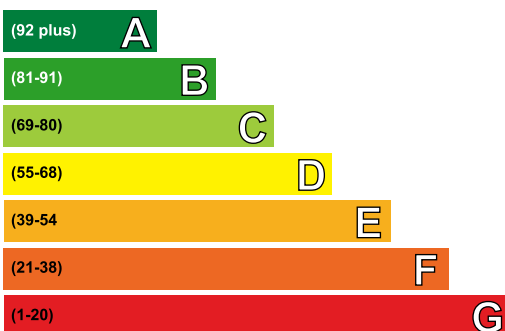
\* based upon the cost of energy for heating, hot water, lighting and ventilation, calculated using standard assumptions

Very energy efficient - lower running costs

Not energy efficient - higher running costs

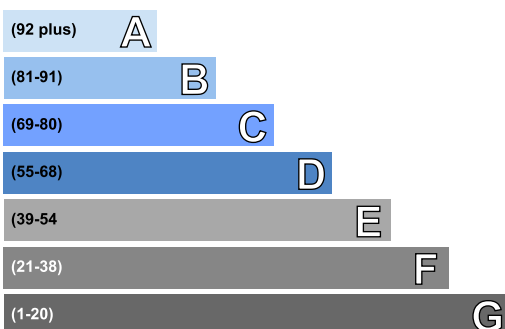
Very environmentally friendly - lower CO<sub>2</sub> emissions

Not environmentally friendly - higher CO<sub>2</sub> emissions
