Single Survey

Property address	58 St. Swithin Street Aberdeen AB10 6XJ
Customer	Jean Fraser
Customer address	58 St. Swithin Street Aberdeen AB10 6XJ
Prepared by	Shepherd Chartered Surveyors
Date of inspection	28/05/2024

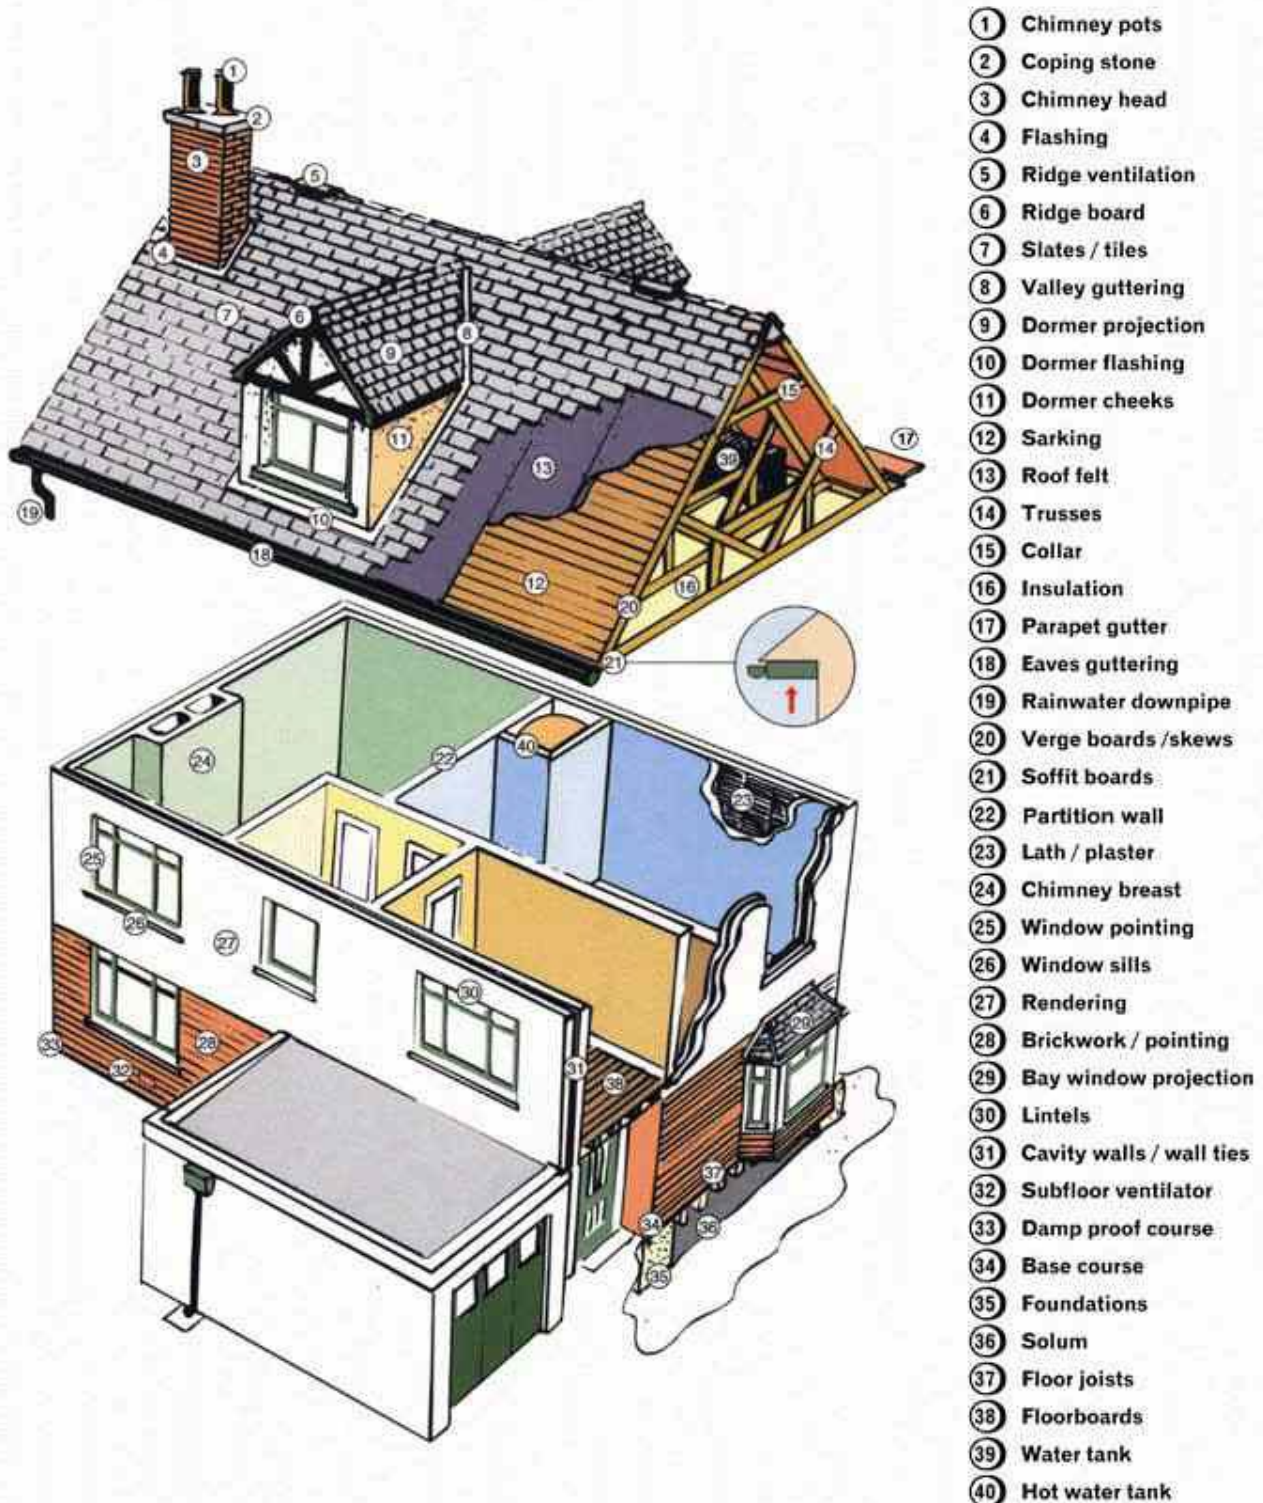
Sectional Diagram showing elements of a typical house

Reference may be made in this report to some or all of the above component parts of the property. This diagram may assist you in locating and understanding these items.
