# HOME REPORT

24 PLADDA AVENUE  
BROOMLANDS  
IRVINE  
KA11 1DR

# ENERGY PERFORMANCE CERTIFICATE

# Single Survey

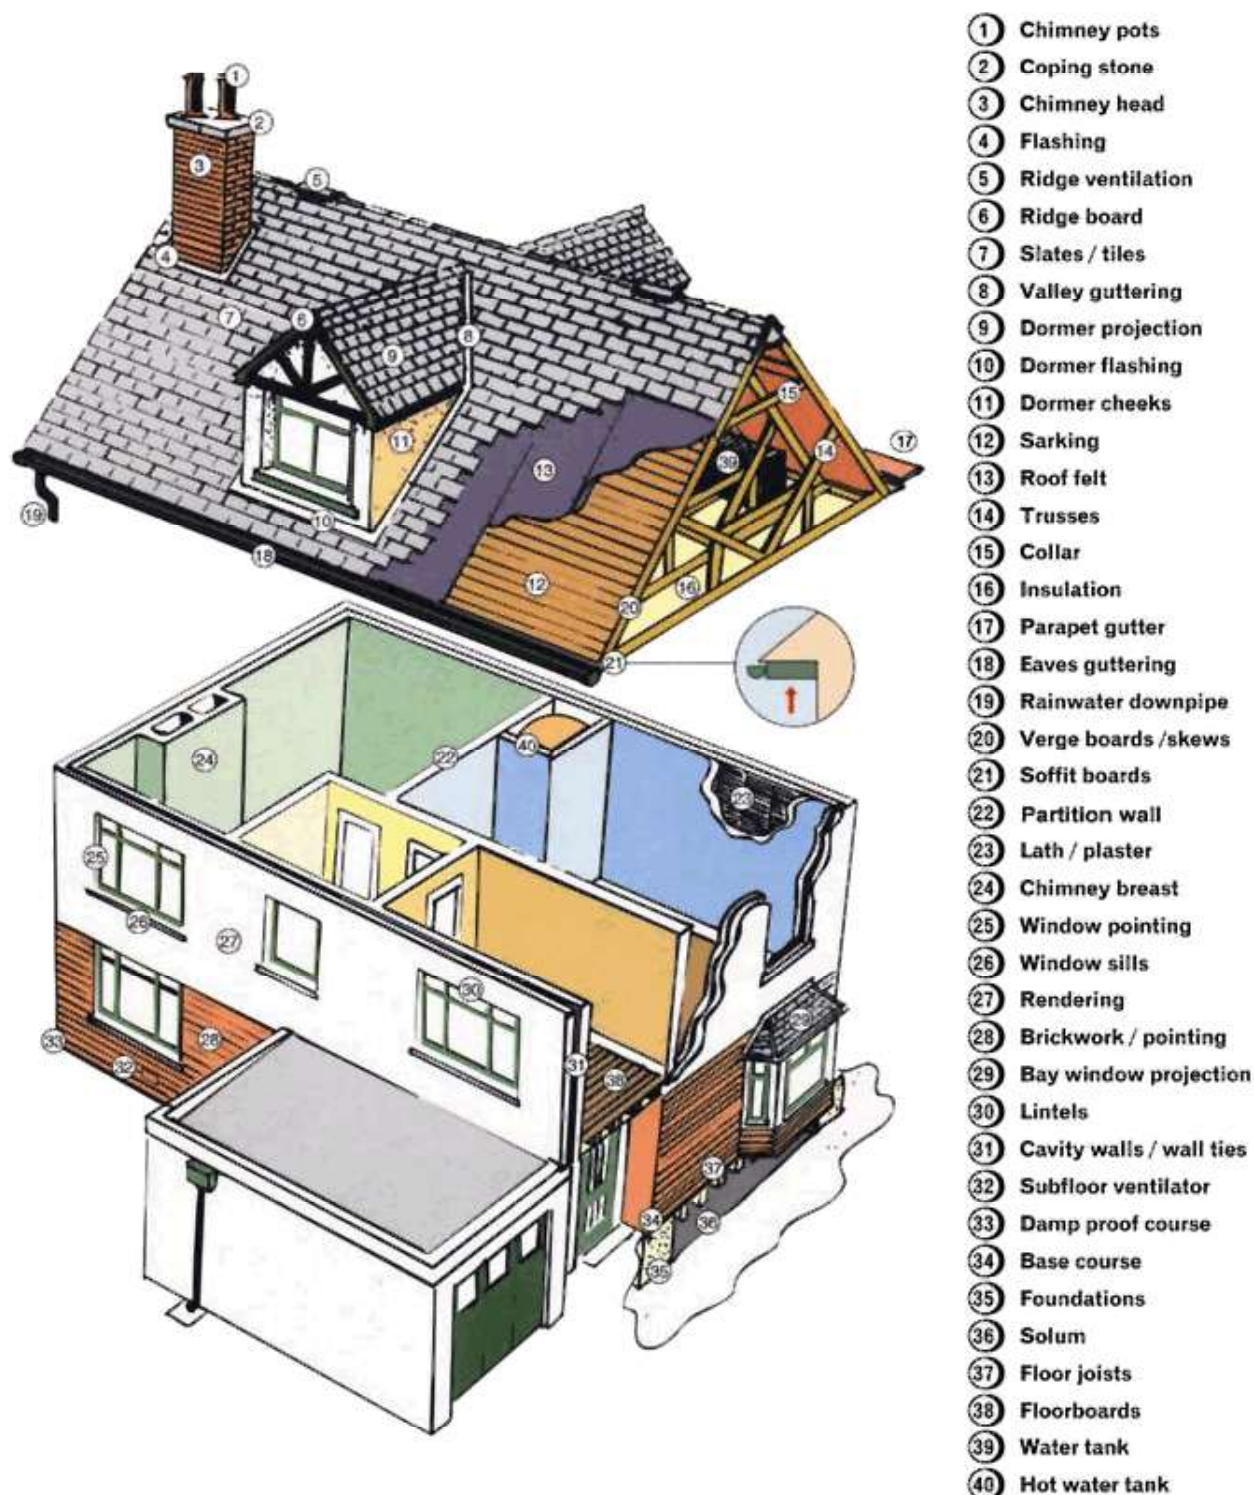
## Sectional Diagram showing elements of a typical house

Reference may be made in this report to some or all of the above component parts of the property. This diagram may assist you in locating and understanding these items.
