# Single Survey

| Property address | Flat 0/1,<br>548 Hamilton Road,<br>Glasgow,<br>G71 7SG |
| Prepared by | Allied Surveyors Scotland Ltd |
| Date of inspection | 12th August 2025 |

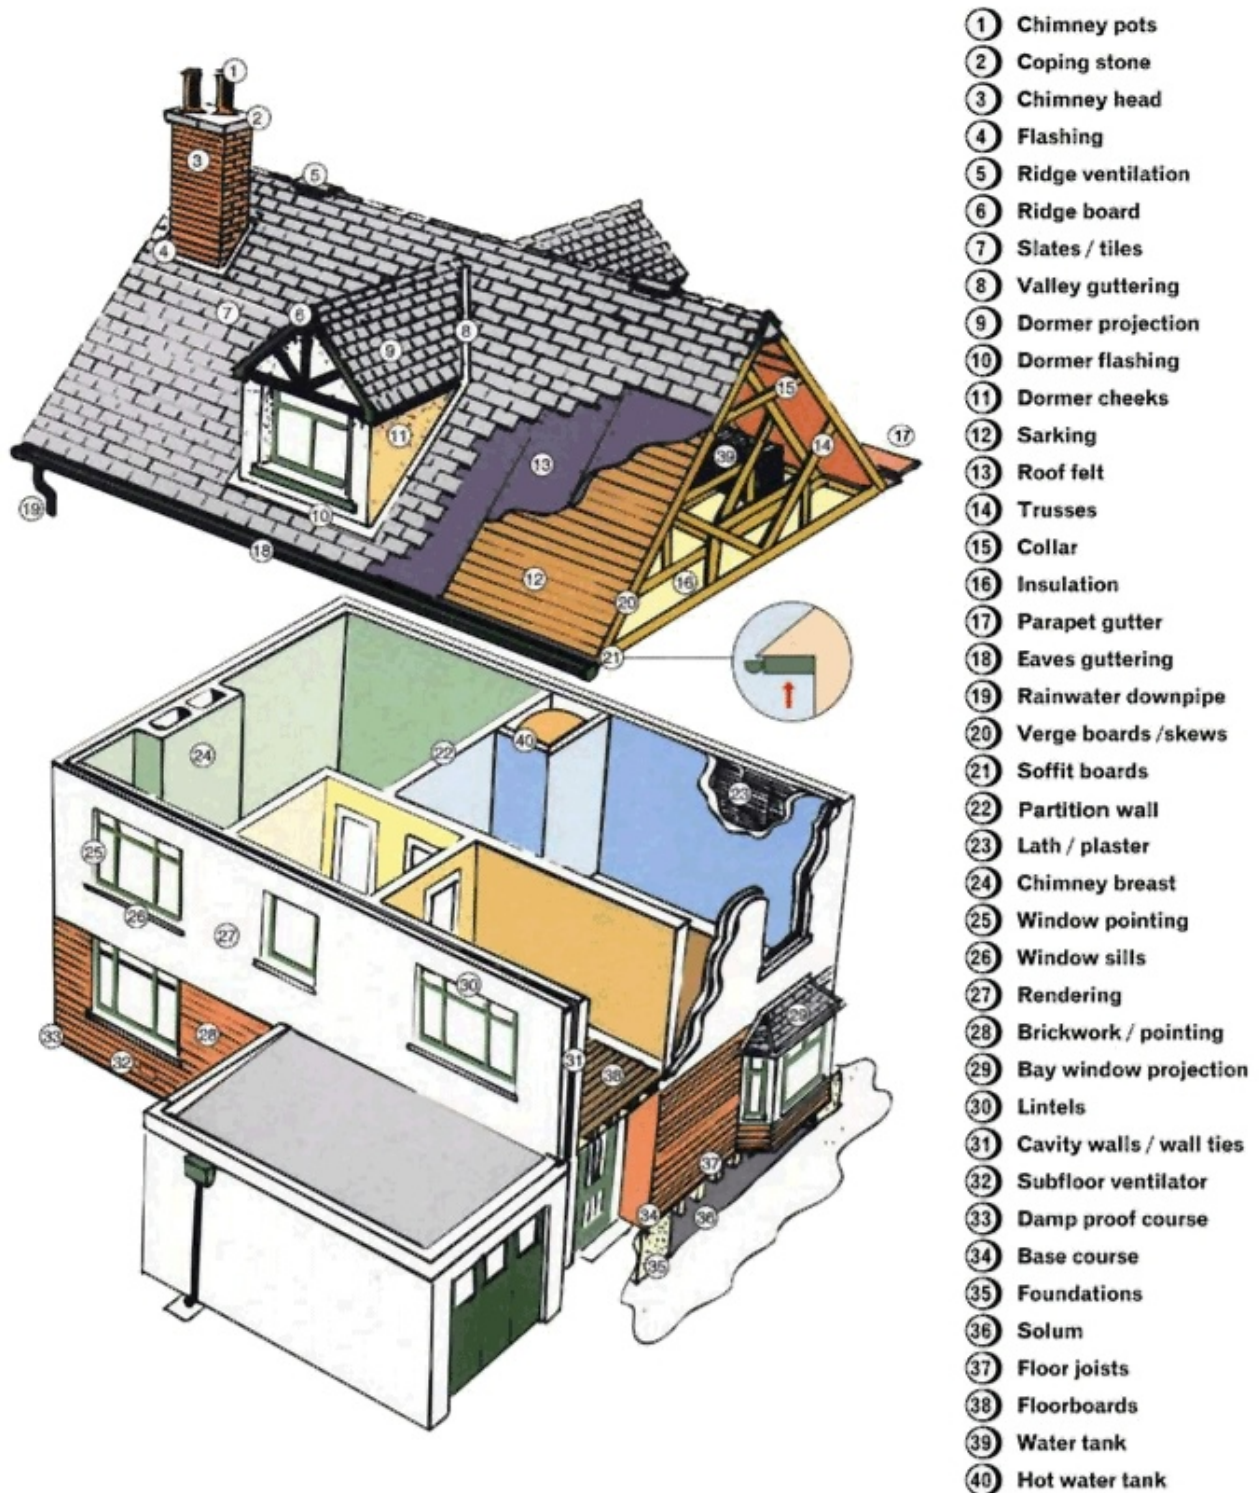
## Sectional Diagram showing elements of a typical house

Reference may be made in this report to some or all of the above component parts of the property. This diagram may assist you in locating and understanding these items.
