**HOME**  
report

SINGLE SURVEY  
ENERGY REPORT  
PROPERTY QUESTIONNAIRE  
VALUATION REPORT

| <b>Property Address</b> | Flat 29 Greenwood Grove West Stewarton Road Newton Mearns<br>Glasgow G77 6ZF |
| <b>Prepared by</b> | R Fitzpatrick<br>Harvey Donaldson & Gibson Chartered Surveyors |

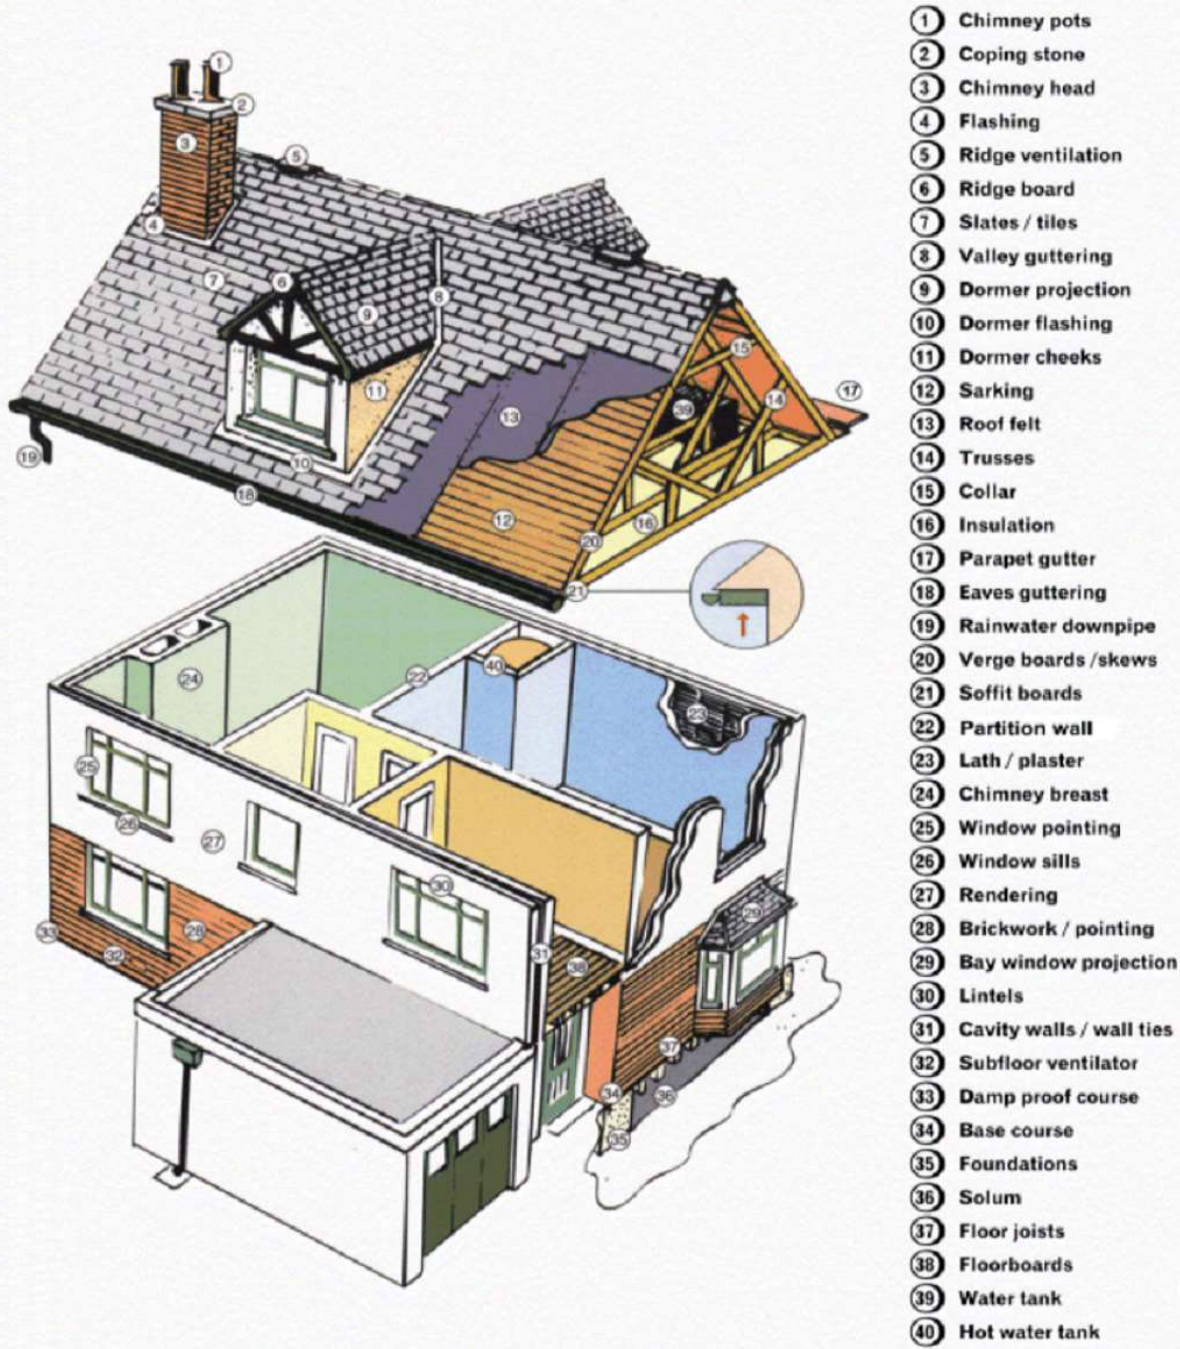
**Sectional Diagram showing elements of a typical house**

Reference may be made in this report to some or all of the above component parts of the property. This diagram may assist you in locating and understanding these items.

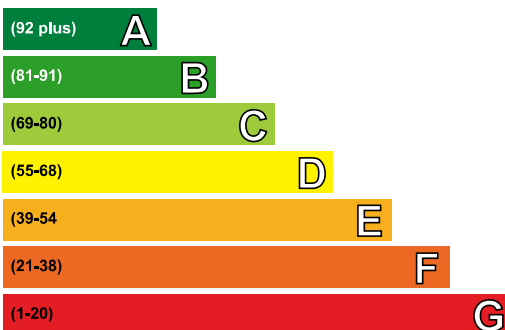
\* based upon the cost of energy for heating, hot water, lighting and ventilation, calculated using standard assumptions

Very energy efficient - lower running costs

Not energy efficient - higher running costs

The potential rating shows the effect of undertaking all of the improvement measures listed within your recommendations report.

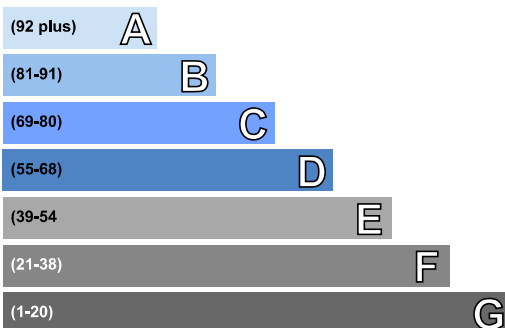
Very environmentally friendly - lower CO<sub>2</sub> emissions

Not environmentally friendly - higher CO<sub>2</sub> emissions
