# home report

**21B WARDROP STREET  
PAISLEY  
PA1 2JA**

21B WARDROP STREET, PAISLEY, PA1 2JA

**Dwelling type:** Mid-floor maisonette  
**Date of assessment:** 04 November 2025  
**Date of certificate:** 04 November 2025  
**Total floor area:** 81 m<sup>2</sup>  
**Primary Energy Indicator:** 189 kWh/m<sup>2</sup>/year

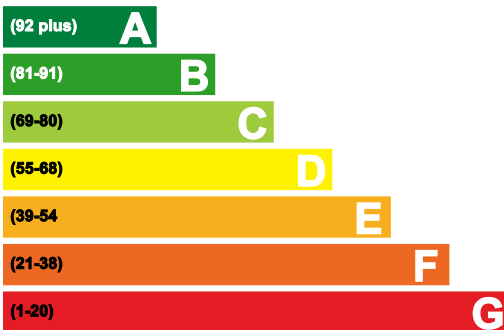
## Energy Efficiency Rating

This graph shows the current efficiency of your home, taking into account both energy efficiency and fuel costs. The higher this rating, the lower your fuel bills are likely to be.

Your current rating is **band C (71)**. The average rating for EPCs in Scotland is **band D (61)**.

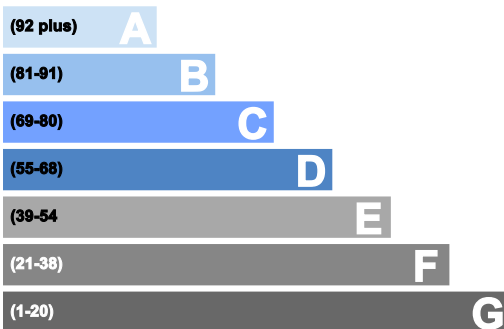
Very environmentally friendly - lower CO<sub>2</sub> emissions

Not environmentally friendly - higher CO<sub>2</sub> emissions

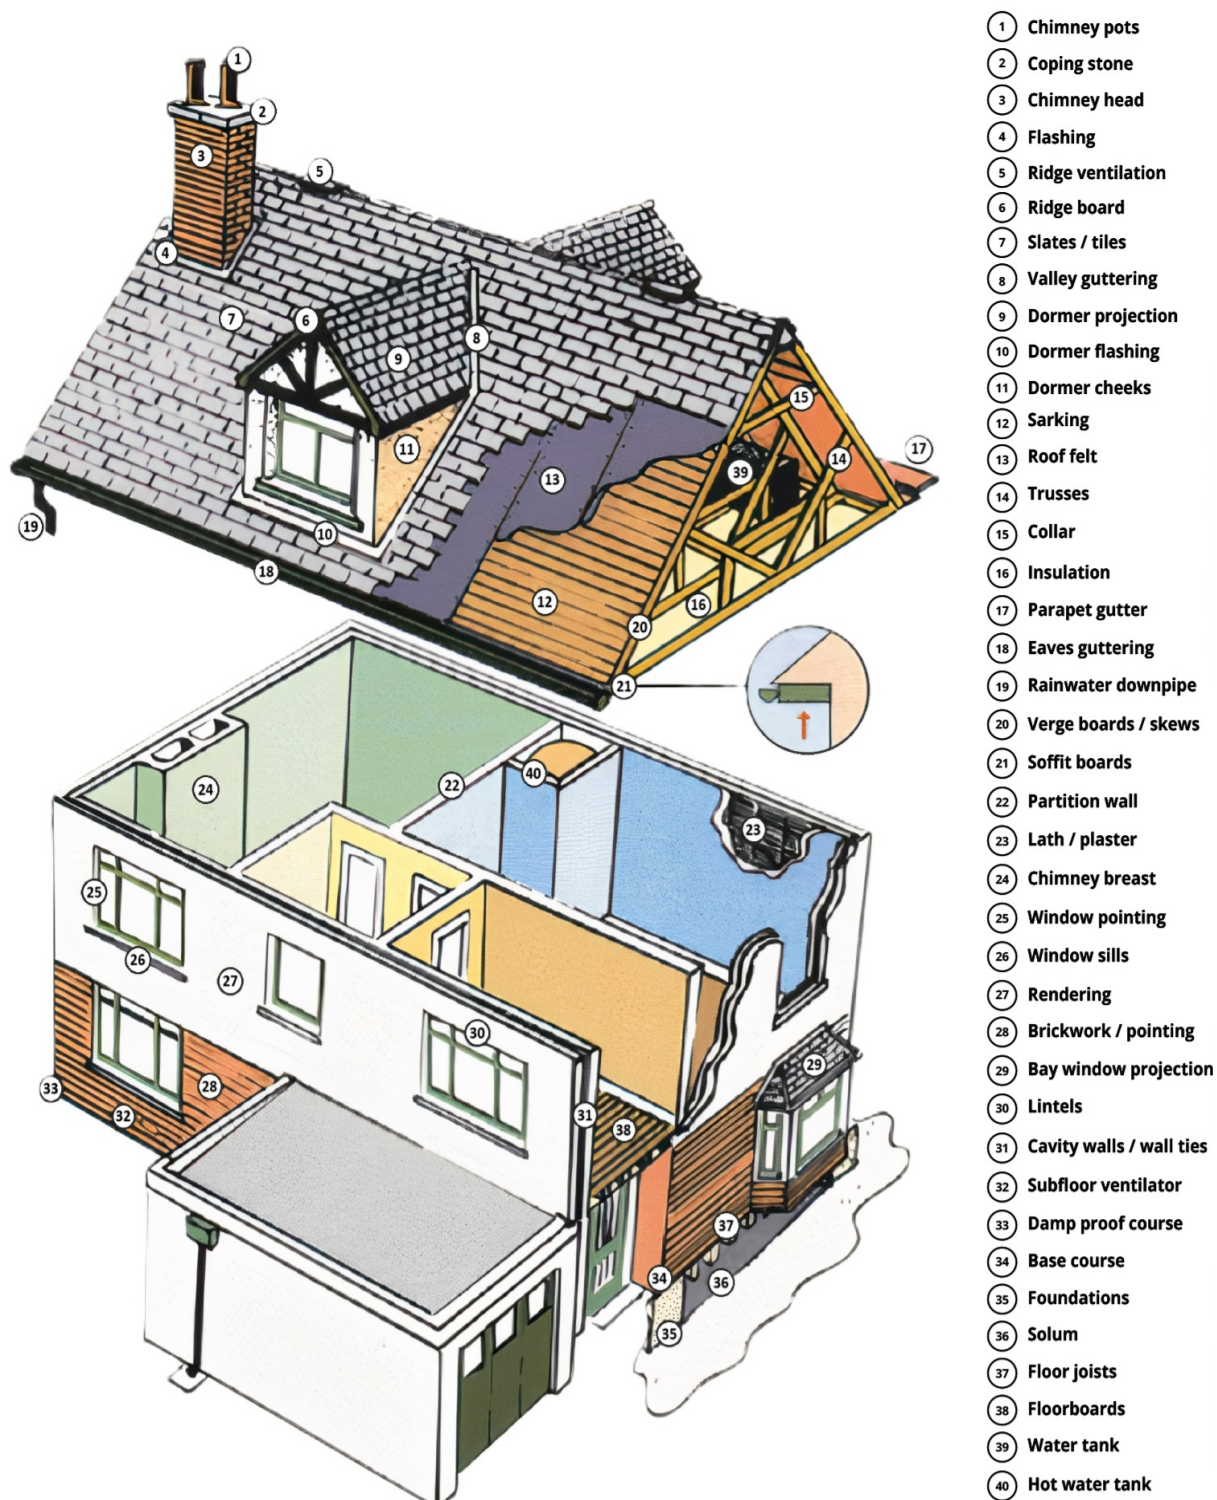
## Sectional Diagram showing elements of a typical house

Reference may be made in this report to some or all of the above component parts of the property. This diagram may assist you in locating and understanding these items.
