YOUR ONESURVEY  
**HOME REPORT**

Flat 1/2  
20 Castle Street  
Rothesay, Isle of Bute  
PA20 9HA

# SINGLE SURVEY

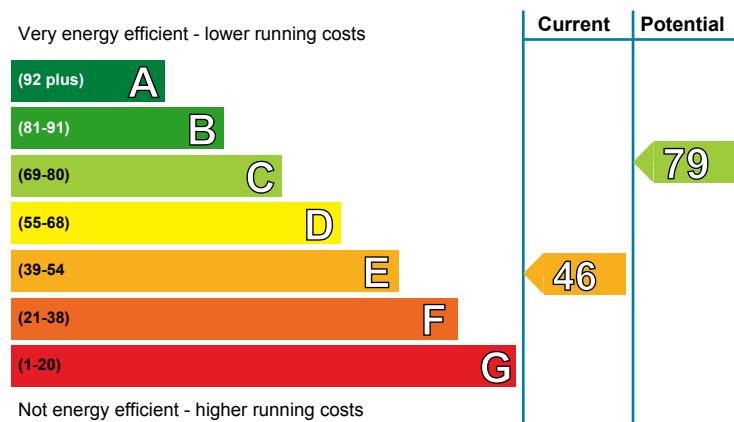
## Energy Efficiency Rating

This graph shows the current efficiency of your home, taking into account both energy efficiency and fuel costs. The higher this rating, the lower your fuel bills are likely to be.

Your current rating is **band E (46)**. The average rating for EPCs in Scotland is **band D (61)**.

The potential rating shows the effect of undertaking all of the improvement measures listed within your recommendations report.

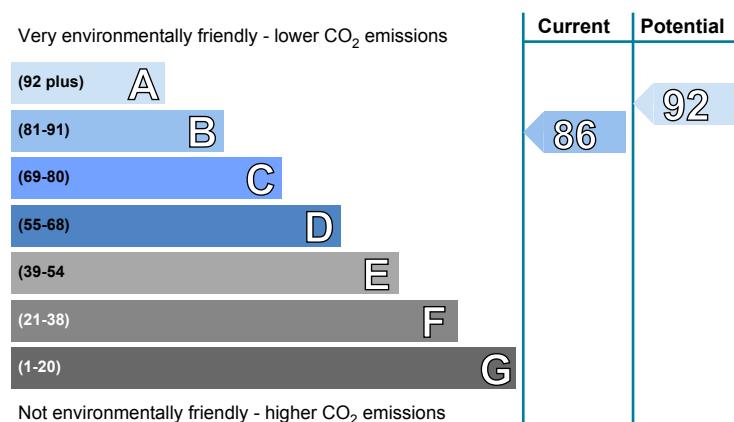
## Environmental Impact (CO<sub>2</sub>) Rating

This graph shows the effect of your home on the environment in terms of carbon dioxide (CO<sub>2</sub>) emissions. The higher the rating, the less impact it has on the environment.
