# property questionnaire

| <b>Property address</b> | <b>41 Middlemuir Road<br/>Inverurie<br/>AB51 4RA</b> |

# Single Survey

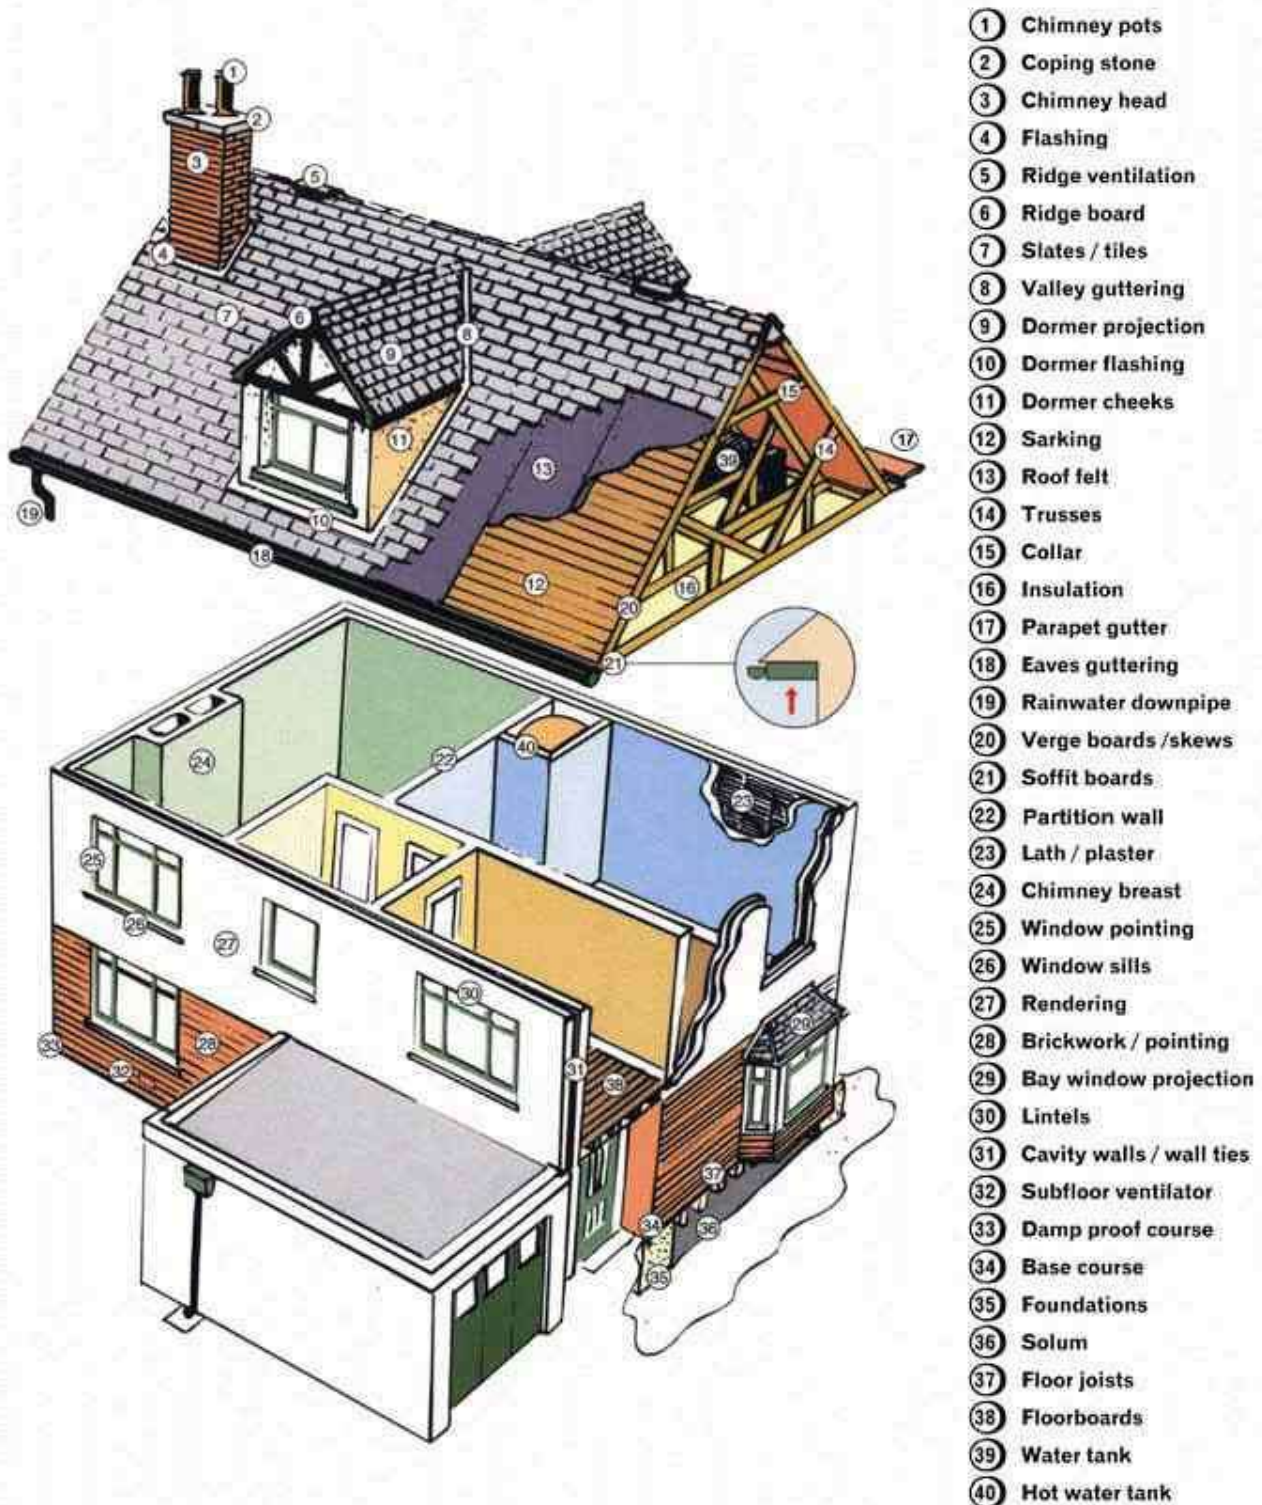
## Sectional Diagram showing elements of a typical house

Reference may be made in this report to some or all of the above component parts of the property. This diagram may assist you in locating and understanding these items.

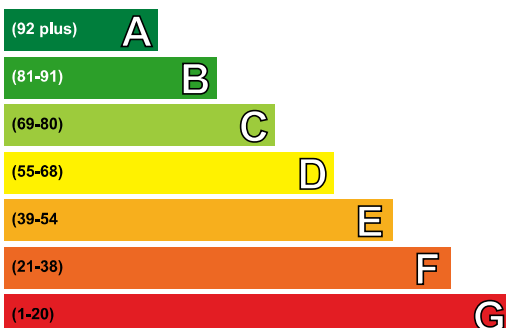
\* based upon the cost of energy for heating, hot water, lighting and ventilation, calculated using standard assumptions

Very energy efficient - lower running costs

Not energy efficient - higher running costs

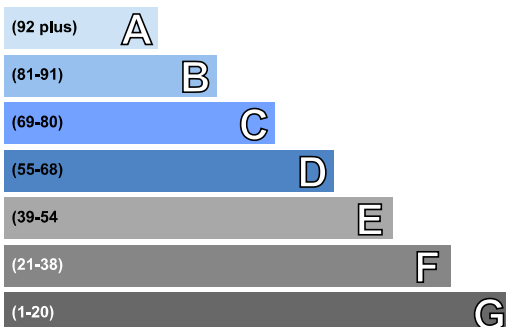
Very environmentally friendly - lower CO<sub>2</sub> emissions

Not environmentally friendly - higher CO<sub>2</sub> emissions
