Single Survey Report

Burnside Whalsay

1. INFORMATION AND SCOPE OF INSPECTION

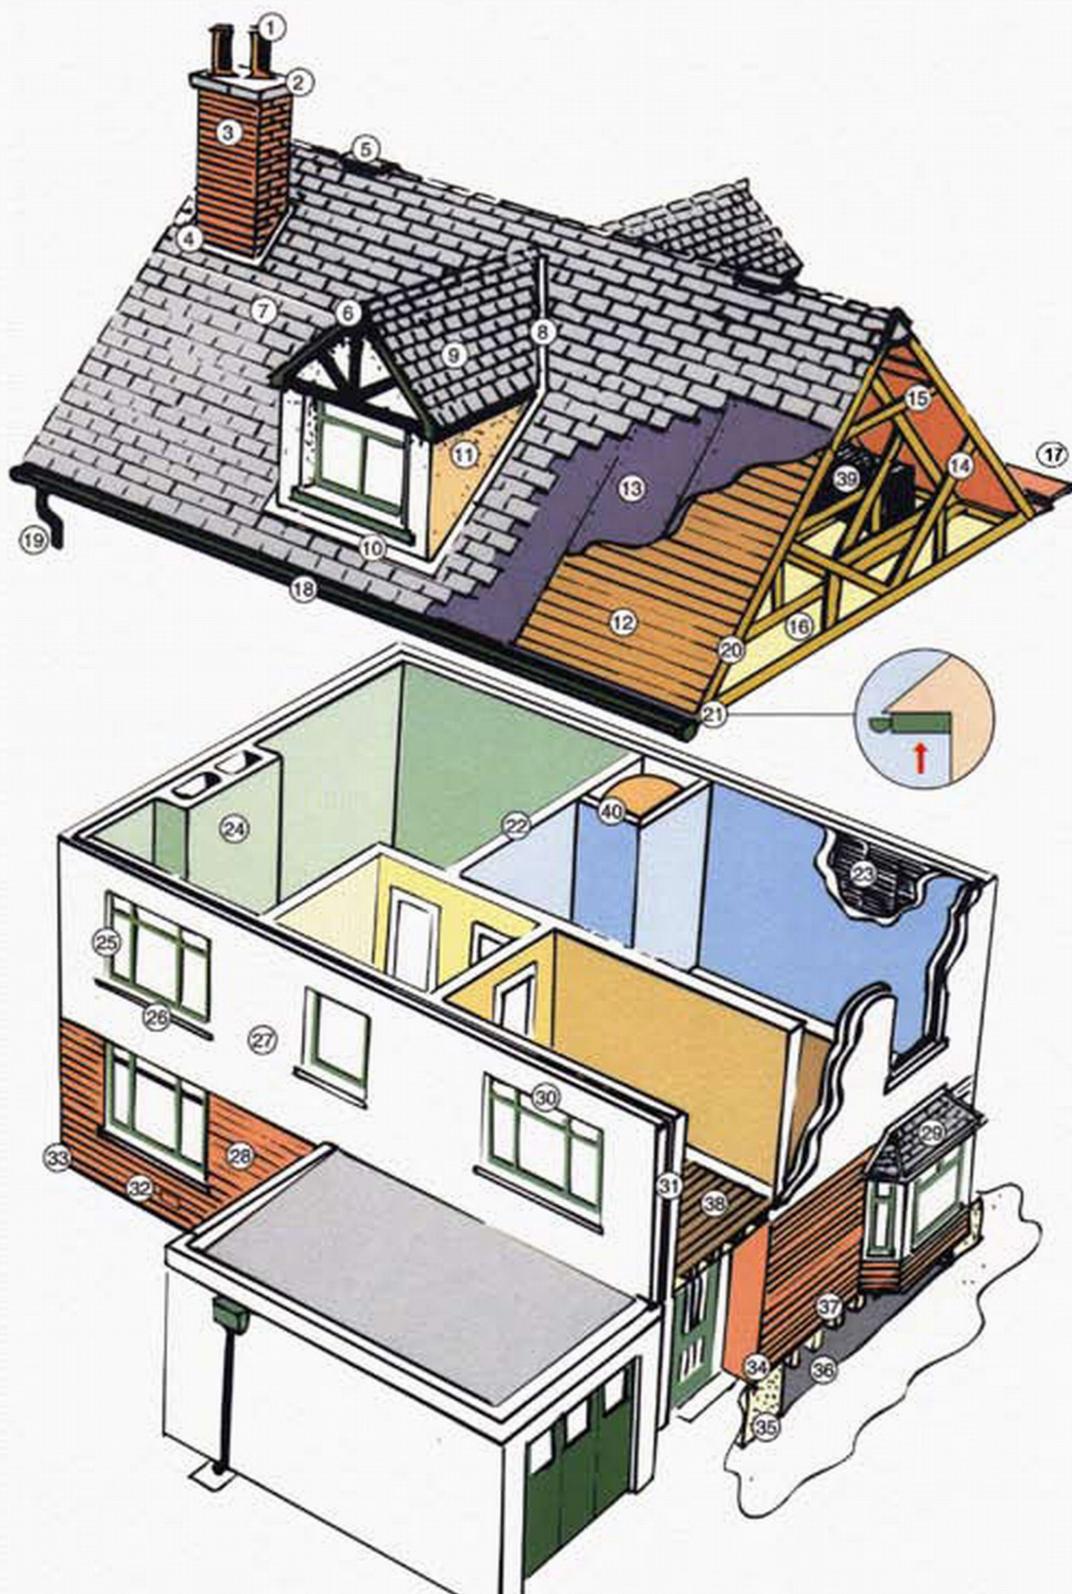
Sectional diagram showing elements of a typical house

- 1 Chimney pots
- 2 Coping stone
- 3 Chimney head
- 4 Flashing
- 5 Ridge ventilation
- 6 Ridge board
- 7 Slates / tiles
- 8 Valley guttering
- 9 Dormer projection
- 10 Dormer flashing
- 11 Dormer cheeks
- 12 Sarking
- 13 Roof felt
- 14 Trusses
- 15 Collar
- 16 Insulation
- 17 Parapet gutter
- 18 Eaves guttering
- 19 Rainwater downpipe
- 20 Verge boards /skews
- 21 Soffit boards
- 22 Partition wall
- 23 Lath / plaster
- 24 Chimney breast
- 25 Window pointing
- 26 Window sills
- 27 Rendering
- 28 Brickwork / pointing
- 29 Bay window projection
- 30 Lintels
- 31 Cavity walls / wall ties
- 32 Subfloor ventilator
- 33 Damp proof course
- 34 Base course
- 35 Foundations
- 36 Solum
- 37 Floor joists
- 38 Floorboards
- 39 Water tank
- 40 Hot water tank

Reference may be made in this report to some or all of the above component parts of the property. This diagram may assist you in locating and understanding these terms.
