home report

**36 KINTORE PLACE
ABERDEEN
AB25 2TP**

Energy Performance Certificate (EPC)

36 KINTORE PLACE, ABERDEEN, AB25 2TP

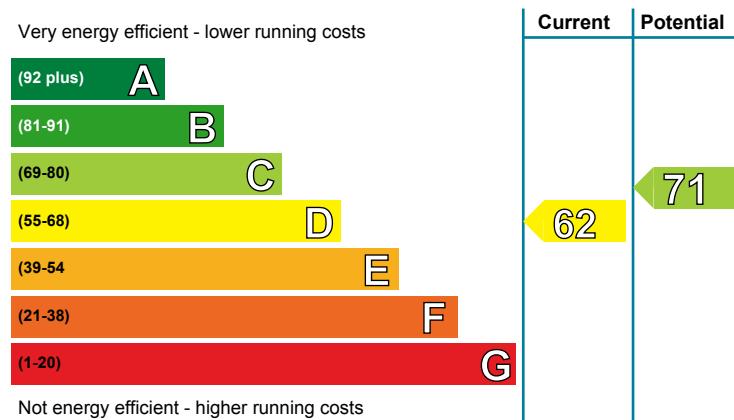
Energy Efficiency Rating

This graph shows the current efficiency of your home, taking into account both energy efficiency and fuel costs. The higher this rating, the lower your fuel bills are likely to be.

Your current rating is **band D (62)**. The average rating for EPCs in Scotland is **band D (61)**.

The potential rating shows the effect of undertaking all of the improvement measures listed within your recommendations report.

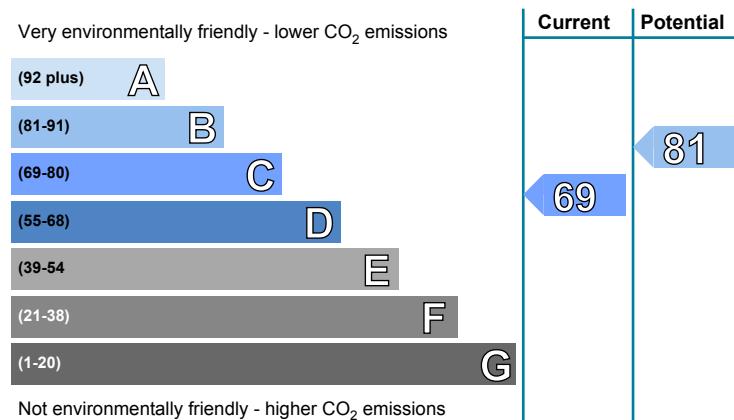
Environmental Impact (CO₂) Rating

This graph shows the effect of your home on the environment in terms of carbon dioxide (CO₂) emissions. The higher the rating, the less impact it has on the environment.

Your current rating is **band C (69)**

The potential rating shows the effect of undertaking all of the improvement measures listed within your recommendations report.
