YOUR ONESURVEY
HOME REPORT

1/R
337 Strathmartine Road
Dundee
DD3 8NE

HOME REPORT

SINGLE SURVEY

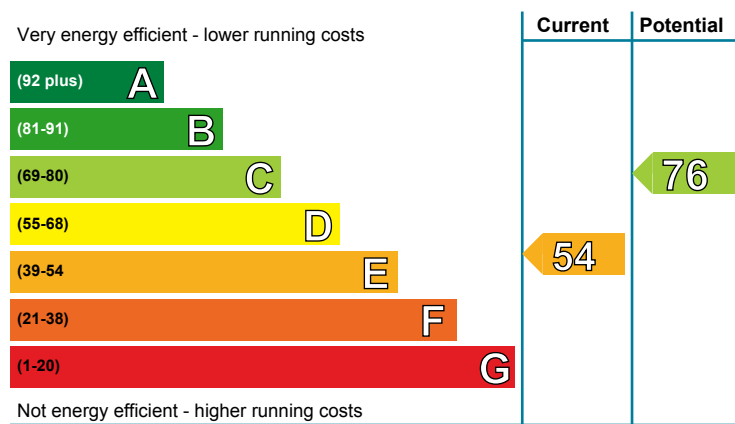
Energy Efficiency Rating

This graph shows the current efficiency of your home, taking into account both energy efficiency and fuel costs. The higher this rating, the lower your fuel bills are likely to be.

Your current rating is **band E (54)**. The average rating for EPCs in Scotland is **band D (61)**.

The potential rating shows the effect of undertaking all of the improvement measures listed within your recommendations report.

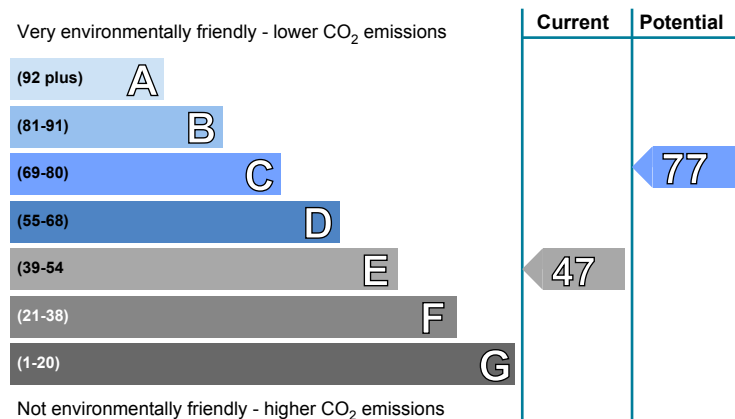
Environmental Impact (CO₂) Rating

This graph shows the effect of your home on the environment in terms of carbon dioxide (CO₂) emissions. The higher the rating, the less impact it has on the environment.
