YOUR ONESURVEY
HOME REPORT

7 Elm Court
Elm Street
Dundee
DD2 2AX

SINGLE SURVEY

A report on the condition of the property, with categories being rated from 1 to 3.

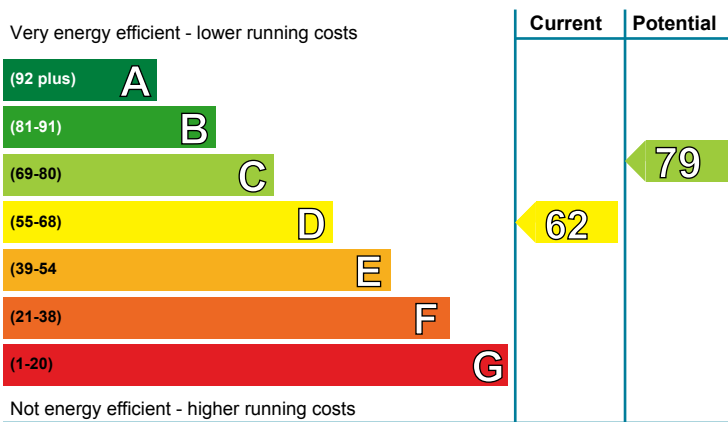
Energy Efficiency Rating

This graph shows the current efficiency of your home, taking into account both energy efficiency and fuel costs. The higher this rating, the lower your fuel bills are likely to be.

Your current rating is **band D (62)**. The average rating for EPCs in Scotland is **band D (61)**.

The potential rating shows the effect of undertaking all of the improvement measures listed within your recommendations report.

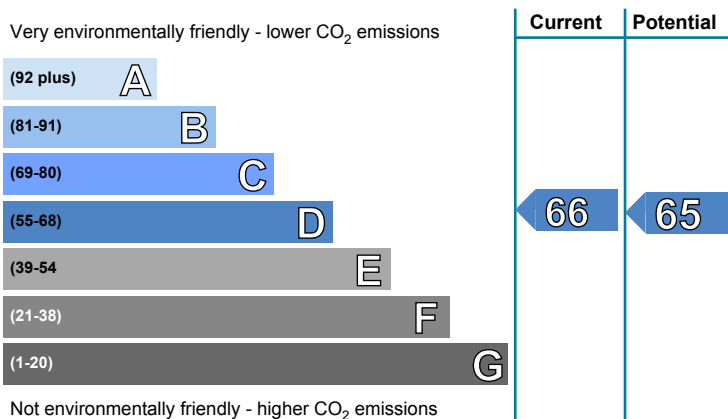
Environmental Impact (CO₂) Rating

This graph shows the effect of your home on the environment in terms of carbon dioxide (CO₂) emissions. The higher the rating, the less impact it has on the environment.
