Home Report

3 A Douglas Terrace
Dundee
DD3 6HN

single survey

Property address	3 A Douglas Terrace Dundee DD3 6HN
Customer	Mr Davidson
Prepared by	Graham + Sibbald LLP

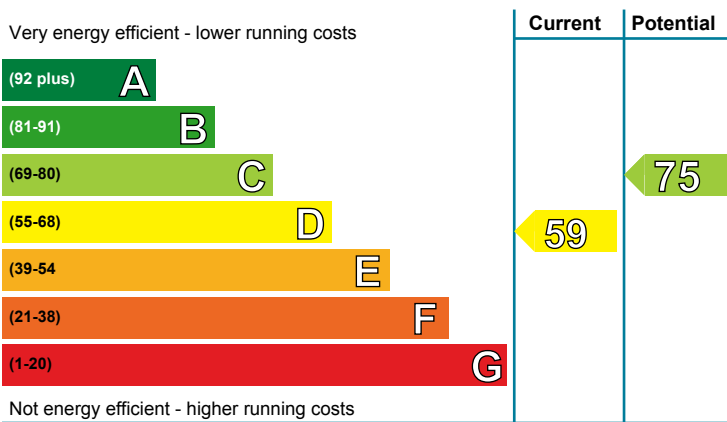
Energy Efficiency Rating

This graph shows the current efficiency of your home, taking into account both energy efficiency and fuel costs. The higher this rating, the lower your fuel bills are likely to be.

Your current rating is **band D (59)**. The average rating for EPCs in Scotland is **band D (61)**.

The potential rating shows the effect of undertaking all of the improvement measures listed within your recommendations report.

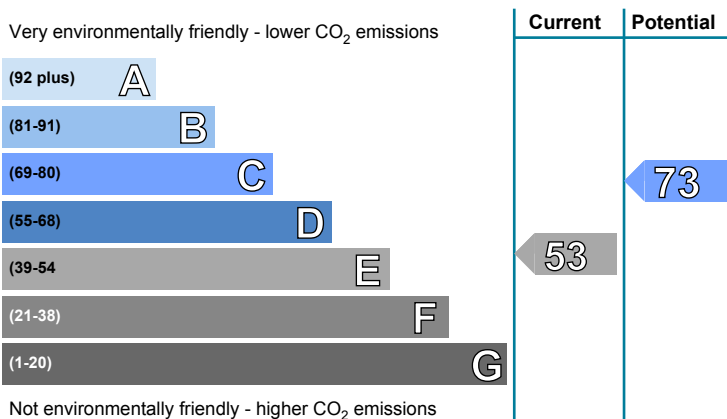
Environmental Impact (CO₂) Rating

This graph shows the effect of your home on the environment in terms of carbon dioxide (CO₂) emissions. The higher the rating, the less impact it has on the environment.
