# YOUR ONESURVEY HOME REPORT

29 Taylors Lane
Dundee
DD2 1AP

## SINGLE SURVEY

## Single Survey

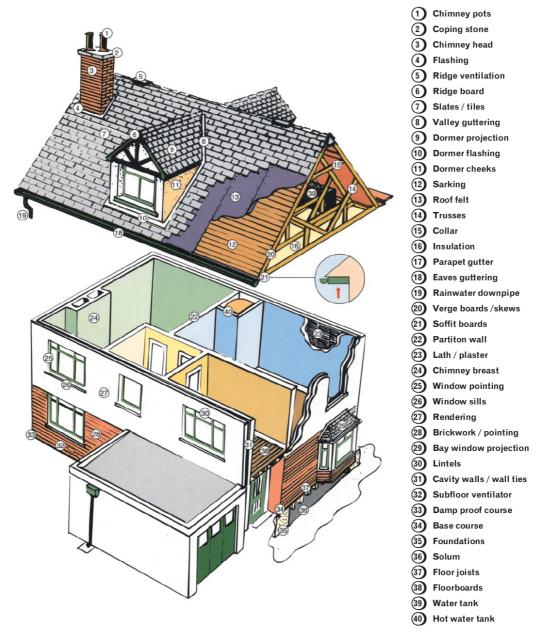
#### Sectional Diagram showing elements of a typical house

Reference may be made in this report to some or all of the above component parts of the property. This diagram may assist you in locating and understanding these items.
