Home Report

Scottish Single Survey

Property address	Rawes Farmhouse Longforgan Dundee DD2 5HQ
-------------------------	--

Prepared by	Shepherd Chartered Surveyors
--------------------	------------------------------

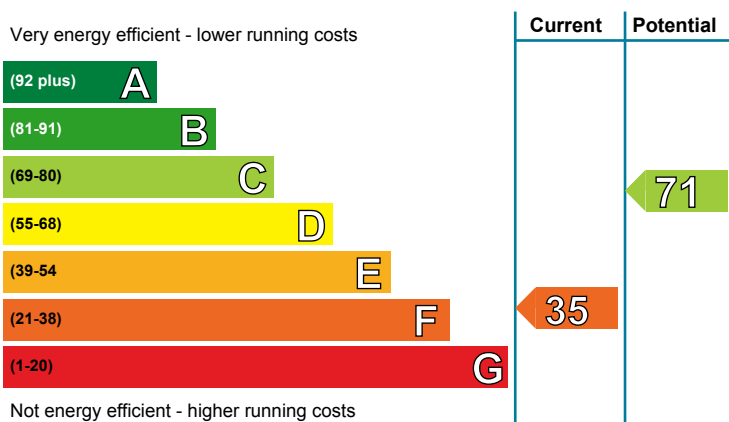
Energy Efficiency Rating

This graph shows the current efficiency of your home, taking into account both energy efficiency and fuel costs. The higher this rating, the lower your fuel bills are likely to be.

Your current rating is **band F (35)**. The average rating for EPCs in Scotland is **band D (61)**.

The potential rating shows the effect of undertaking all of the improvement measures listed within your recommendations report.

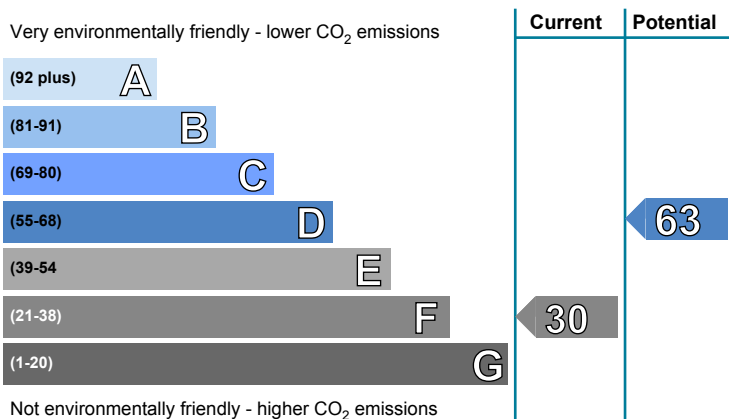
Environmental Impact (CO₂) Rating

This graph shows the effect of your home on the environment in terms of carbon dioxide (CO₂) emissions. The higher the rating, the less impact it has on the environment.
