HOME REPORT

G/1
7 SAGGAR STREET
DUNDEE
DD2 2BZ

Energy Performance Certificate (EPC)

Single Survey

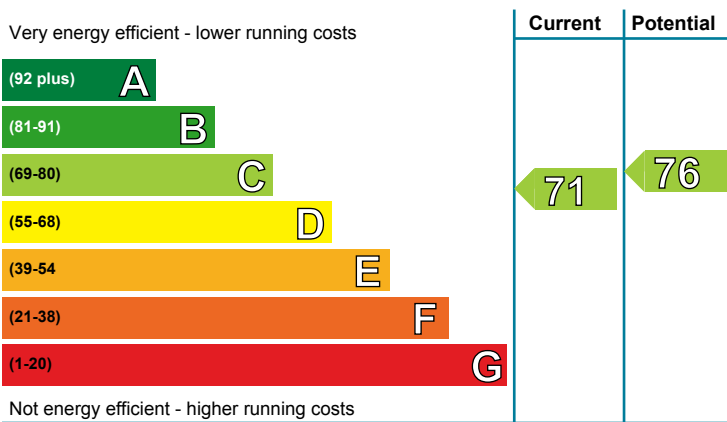
Energy Efficiency Rating

This graph shows the current efficiency of your home, taking into account both energy efficiency and fuel costs. The higher this rating, the lower your fuel bills are likely to be.

Your current rating is **band C (71)**. The average rating for EPCs in Scotland is **band D (61)**.

The potential rating shows the effect of undertaking all of the improvement measures listed within your recommendations report.

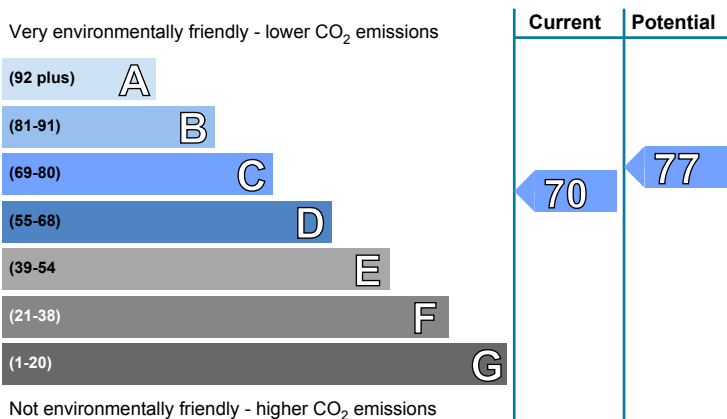
Environmental Impact (CO₂) Rating

This graph shows the effect of your home on the environment in terms of carbon dioxide (CO₂) emissions. The higher the rating, the less impact it has on the environment.

Your current rating is **band C (70)**. The average rating for EPCs in Scotland is **band D (59)**.

The potential rating shows the effect of undertaking all of the improvement measures listed within your recommendations report.
