# Home Report

# Scottish Single Survey

<b>Property address</b>	394d Perth Road Dundee DD2 1JQ
<b>Customer</b>	Places For People Ltd
<b>Customer address</b>	394d Perth Road Dundee DD2 1JQ
<b>Prepared by</b>	Shepherd Chartered Surveyors
<b>Date of inspection</b>	19/09/2024

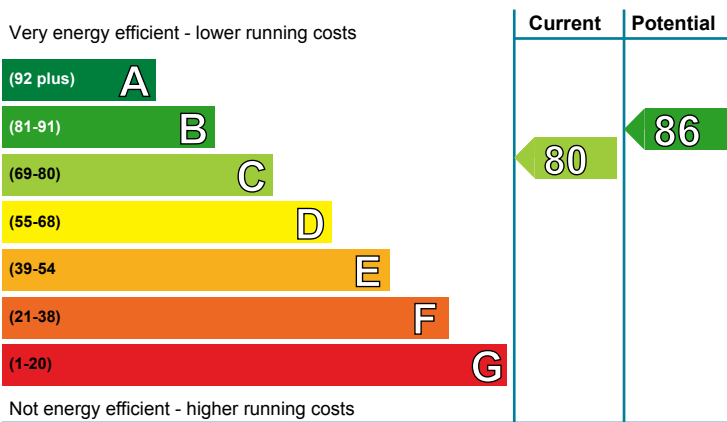
## Energy Efficiency Rating

This graph shows the current efficiency of your home, taking into account both energy efficiency and fuel costs. The higher this rating, the lower your fuel bills are likely to be.

Your current rating is **band C (80)**. The average rating for EPCs in Scotland is **band D (61)**.

The potential rating shows the effect of undertaking all of the improvement measures listed within your recommendations report.
